September 2022

Hustisford School District 2022 FACILITY ASSESSMENT REPORT

Hustisford School District	1 I Summary Statement	4-7
845 South Lake Street Hustisford, WI 53034	2 I Overview	8-15
ARCHITECTURE ENGINEERING INTERIOR DESIGN	3 Site Evaluation	16-21
HSR Associates, Inc.	4 I Building Program Spaces	22-41
100 Milwaukee Street	Elementary School Jr/Sr High School	24-31
La Crosse, WI 54603		32-41
KRAEMER BROTHERS Kraemer Brothers	5 I Building Systems/Engineering HVAC Systems Electrical Systems	42-87 44-67 68-87
925 Park Ave

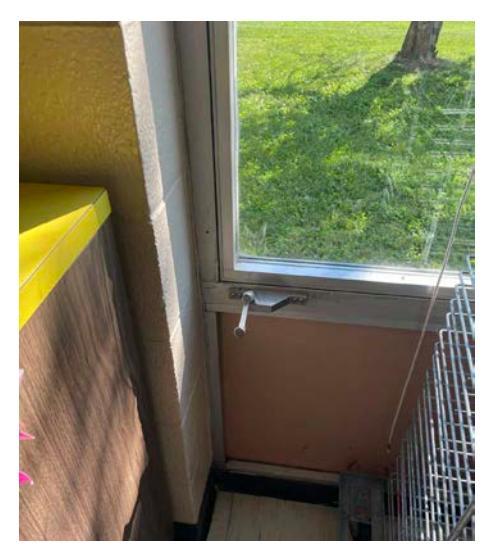
The Elementary School has a very limited amount of windows. Generally each classroom has one 3'-0" wide that extends from the floor to the ceiling. The glass starts a few feet off the ground with a spandrel panel below it. It was noted that many of the windows no longer open as they should. A few rooms like the art room and cafeteria have a few additional windows. A recommendation would be to add additional windows and replace the existing frames for improved efficiency and function. Natural daylight has been shown to improve the feeling of a space and the mood of its occupants.

Existing windows

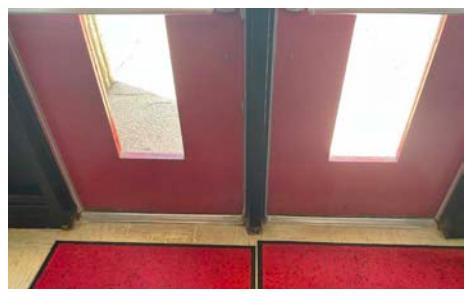
The exterior entrance doors at the end of each hallway are showing their age and beginning to rust. They are hollow metal frames and doors, which require maintenance over time and eventually begin to rust. Recommendation would be to replace the exterior frames and doors.

Rusting door frames

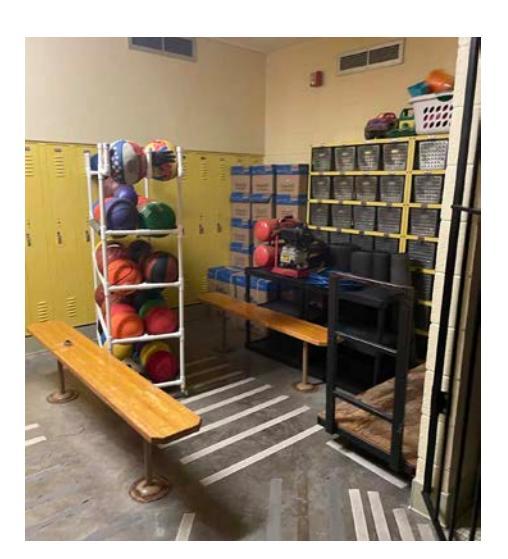
Being built more than 45 years ago, the locker rooms at the Elementary level are not being used to their full potential. The 5th graders use them to change for gym class in preparation to move to the Jr./Sr. High. Otherwise, the locker rooms appear to be used for storage. The shower stalls are not used and the restroom in the locker room is not ADA compliant. Recommendation would be to reconfigure lockers rooms to create changing room, remove the showers to create more gym storage, and renovate the bathrooms to meet ADA.

Storage in Locker Rooms

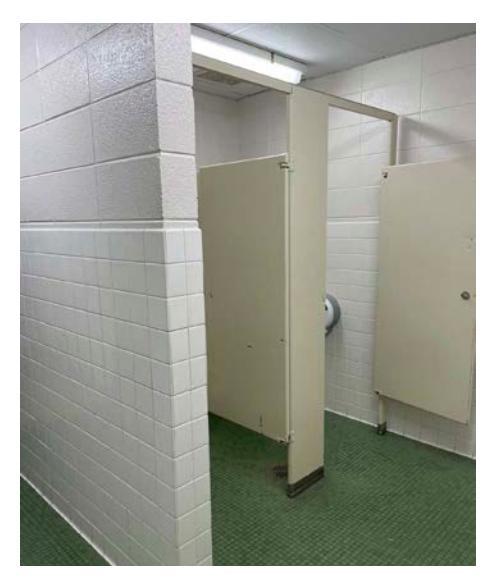
Throughout the elementary school there are handicap accessibility updates that should be made. The primary areas would be to the restrooms, door sizes, and the music room steps. The restrooms are a primary focus, as they are original to the building and undersized. They are located at the beginning of each hallway easily accessible to all. There are two stalls per gender which does meet code. The stalls, however, are too small to meet accessibility. Recommendation would be to expand the restrooms to meet accessibility standards.

Restroom Stalls

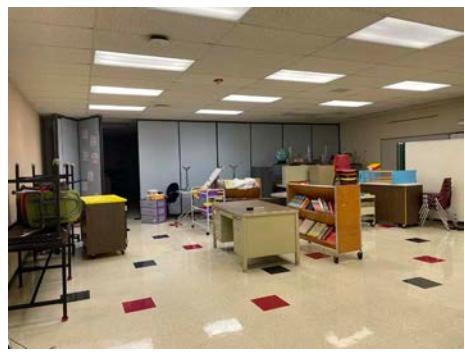
When the building was constructed there were movable partitions planned between a few of the rooms. The intent to create flexibility and collaboration in the classroom spaces was great planning and something we look to include in learning spaces today. However, with only one section per grade, the walls do not get moved very often, and there are a few under utilized rooms. Recommendation would be to renovate the under utilized rooms and update the movable partitions to create more small group collaboration areas. The rooms that adjoin the LMC could be used for STEM classes or activities, creating a useful connection and bridge between classrooms, students and flexible learning spaces.

Classrom with moveable wall

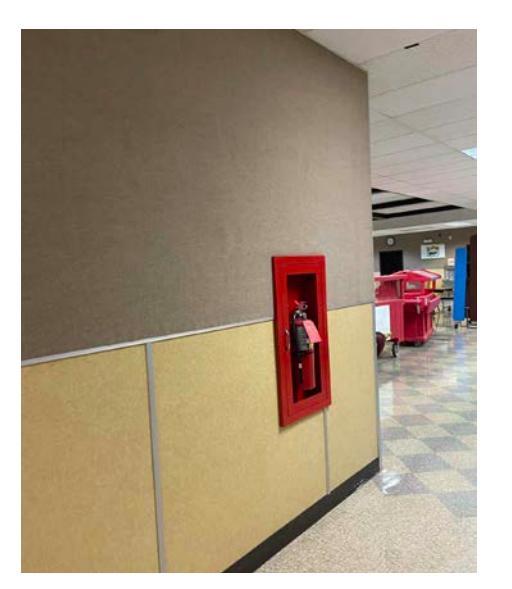
The Jr/Sr High School interior has not changed much since its original construction in 1979. The interior walls are mostly gypsum board and metal studs. The corridor walls have a wall covering along the bottom half and carpet on the upper half that was used for sound control. The flooring throughout the school is mainly VCT. While this type of flooring looks shiny when waxed, it has quite a lot of maintenance with it every year. The library carpet is orange and dated with the wall covering color and could use an update. Wall coverings are only so wide, so every 4'-0" there is a metal strip covering the seam between panels. The recommendation would be to remove all the wall coverings, strips and carpet, and replace with new gypsum board and paint. This will give the building a refreshed updated feel. Replacing the flooring would be recommended as well, to a product that required less maintenance over time to save on costs.

Existing wall covering and carpet

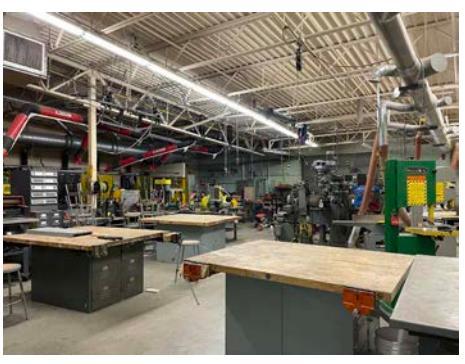
Vocational/ Tech Ed Classroom

The Vocational Education space is undersized for all of the activities and classes it holds. The classroom has space for woods, metals and small automotive. Ideally all of these classes would have their own room. The complexity and amount of equipment for each of these classes is overlapping each other, making the space less than functional for any of them. While the district may not have a need for all separate rooms, we would recommend expanding and renovating the Vocational Education space; to provide the right amount of space for the advances in equipment and teaching practices for these fields of study.

There is a lack of natural daylight as well, and a simple modification would be to replace the overhead garage door with one that has glass in it. The overhead garage door is functional, but it is showing wear and rust along with the main door next to it. The recommendation would be to replace both.

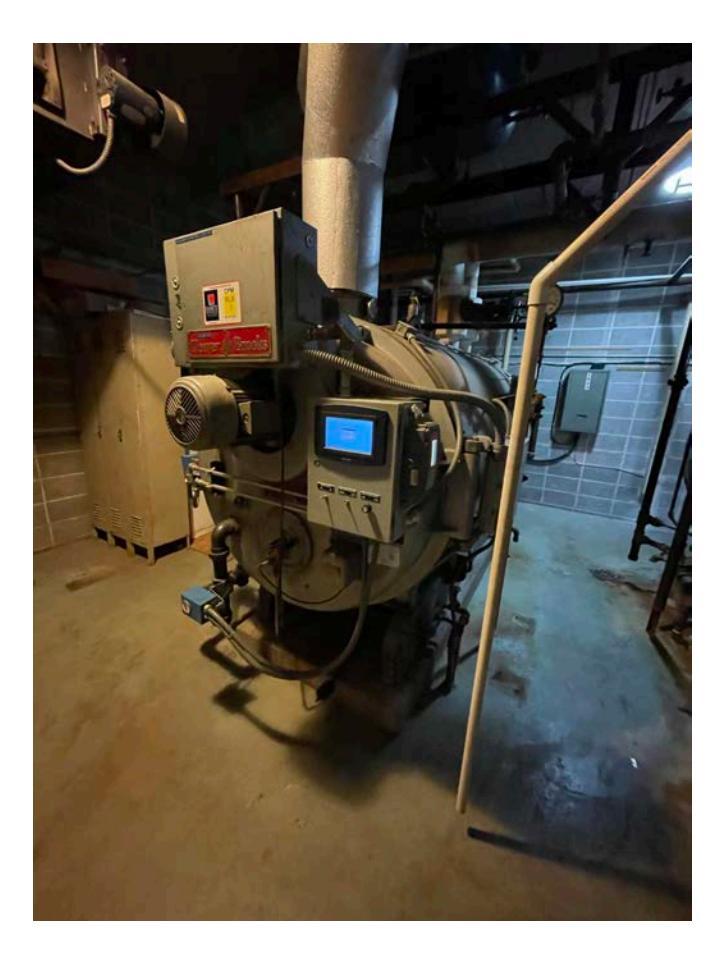
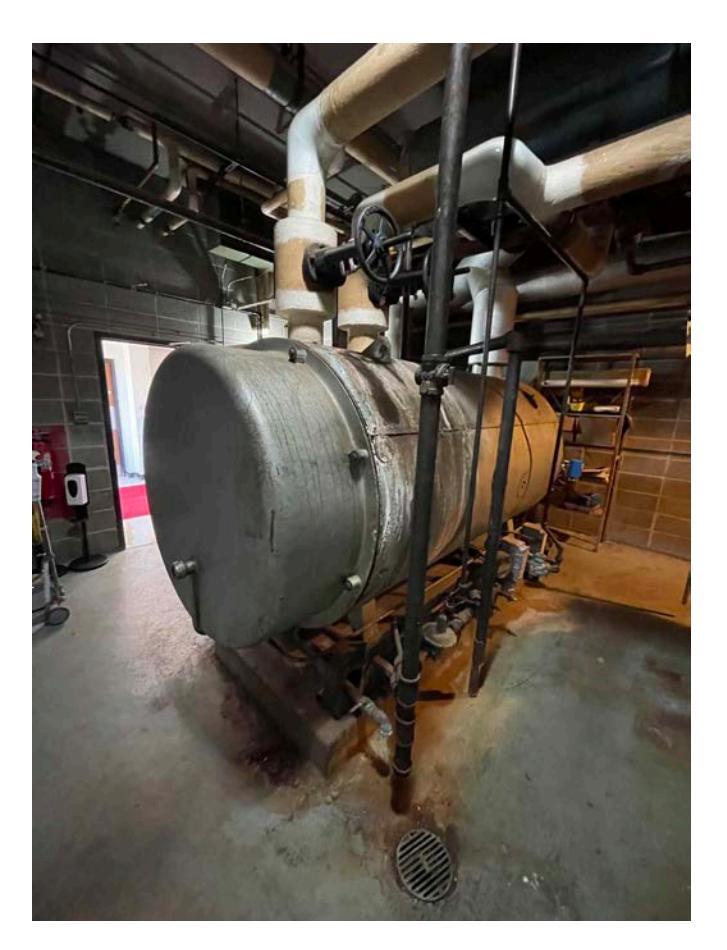
• The building is served by two hot water boilers with hot water piping distributed throughout the building. Both boilers were installed in 1972 and are original to the building.

• The non-condensing boilers (Cleaver Brooks) has an expected useful service life between 25-30 years. The Cleaver Brooks boilers are well beyond their service life and should be planned to be replaced with new condensing style boilers. Condensing boilers allow efficiencies in the +90% when hot water temperatures permit.

• Recommend servicing the boilers and system pumps at the start of every heating season as a preventative maintenance item. Boilers should be tested on natural gas to confirm systems are operating correctly.

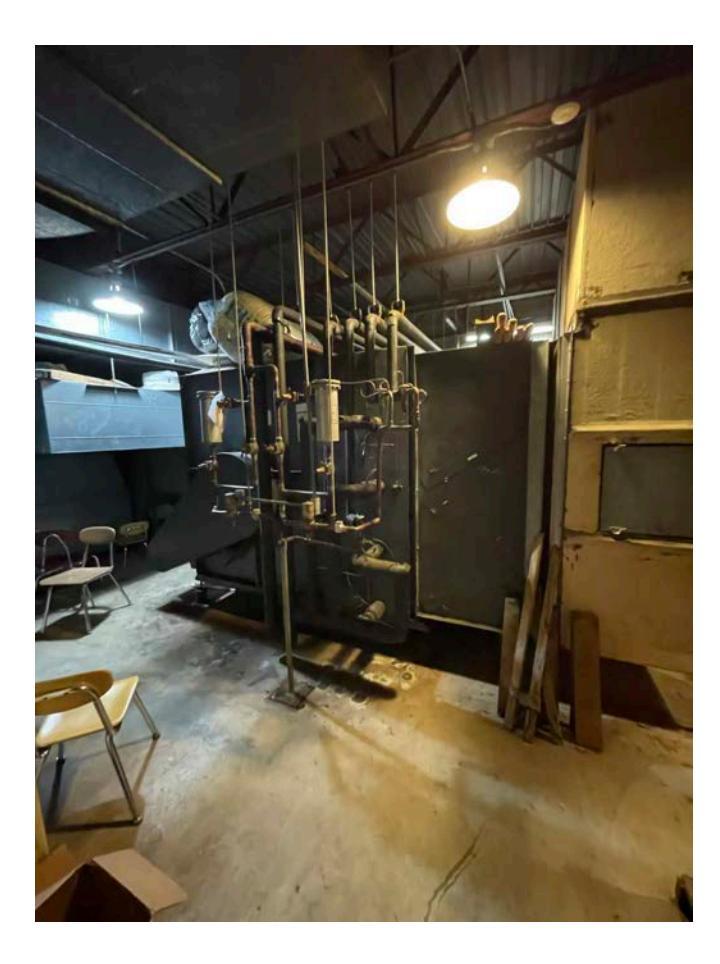
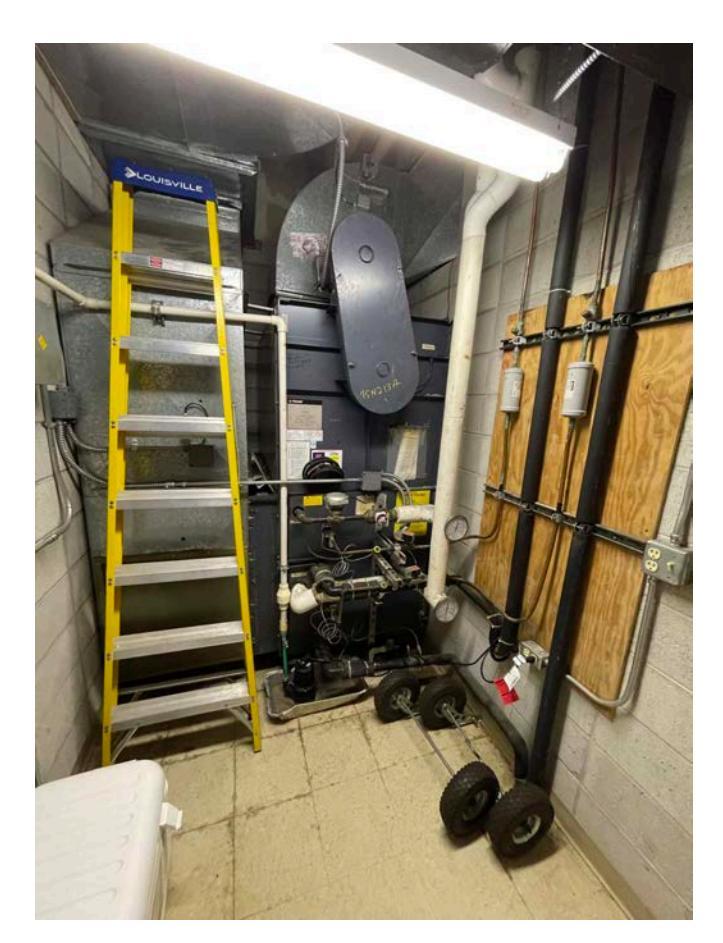
• All supply, outside, relief, return, and exhaust air systems are ducted to the respective equipment. There are portions of the supply, return, and exhaust ductwork that are internally lined for acoustic purposes. All supply ductwork (not internally lined) is externally insulated. Ductwork associated with AHU-5A, serving the addition classrooms, has fiberboard ductwork. This fiberboard ductwork is falling apart, collapsing in areas, and in need of replacement.

• Air handling units have an expected useful service life between 25-30 years. All of the air handling units are well beyond their service life and should be planned to be replaced with new. These units are in need of replacement as the AHU casings are showing signs of rust and deterioration.

• All fiberboard ductwork should be removed and replaced with low or medium pressure sheet metal ductwork. All ductwork should have a seal class A construction in accordance with SMACNA (Sheet Metal and Air Conditioning Contractors' National Association) requirements.
