September 2022

Hustisford School District 2022 FACILITY ASSESSMENT REPORT

Hustisford School District	1 I Summary Statement	4-7
845 South Lake Street Hustisford, WI 53034	2 I Overview	8-15
ARCHITECTURE ENGINEERING INTERIOR DESIGN	3 Site Evaluation	16-21
HSR Associates, Inc.	4 I Building Program Spaces	22-41
100 Milwaukee Street	Elementary School Jr/Sr High School	24-31
La Crosse, WI 54603		32-41
KRAEMER BROTHERS Kraemer Brothers	5 I Building Systems/Engineering HVAC Systems Electrical Systems	42-87 44-67 68-87
925 Park Ave

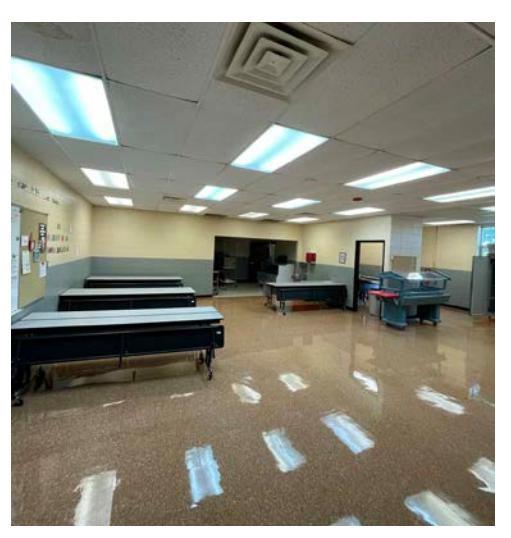
Cafeteria/Auditorium Space (Cafetorium)

The cafeteria is contained within a room to the right of the main entry. Being contained within a room separates it from the rest of the school. It also limits its size and number of students able to eat at one time. The cafeteria also shares space with a small serving line as you enter to the right, and warming kitchen equipment in the back. The food is all cooked at the Jr./Sr. High School and brought over. The floor was not updated with the rest of the school and could use replacing. Our recommendation would be to open the cafeteria up to the main hallway creating a better connection to the school. This would also give the space more elbow room and a few more tables to expand into the hallway a bit during the lunch hour, and then contract back after.

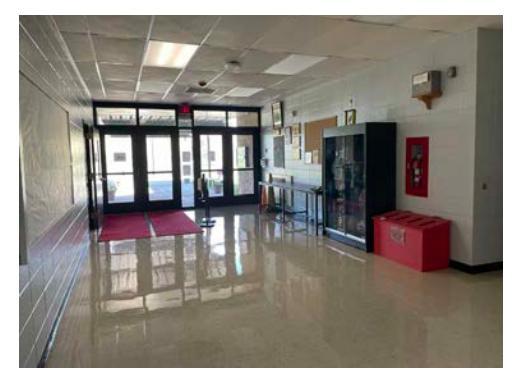
Main Entry

The Elementary School was constructed prior to a two stage entry through the office. With today's school security needs, this is a high priority need that should be addressed. All visitors at non-peak times should be routed through the main entry to the office reception area. A direct line of sight to the vestibule where a visitor is allowed access, is also recommended. A vestibule/entry addition and office reception relocation is recommended to solve this secure entrance need. A vestibule at the entrance will also help energy costs and is required by the energy code now for all main entrances to buildings.

With a remodel of the entry, a new canopy is recommended to replace the worn darker one that is there today. A new canopy can create an identity for the school, bring color and updated lighting to the main entrance.

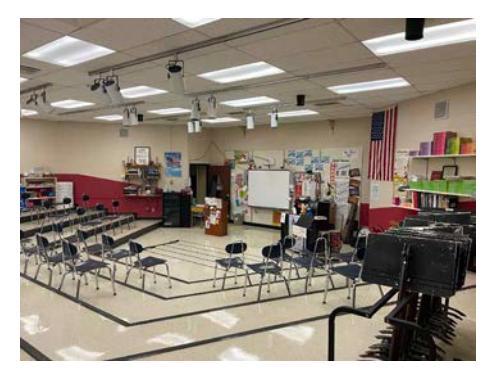
Music Room

The stairs in the music room create a room that is not accessible for all and is an inefficient use of space, as the room is not used for performances as originally intented. Recommendation to fill in the floor to create a more flexible and accessible space.

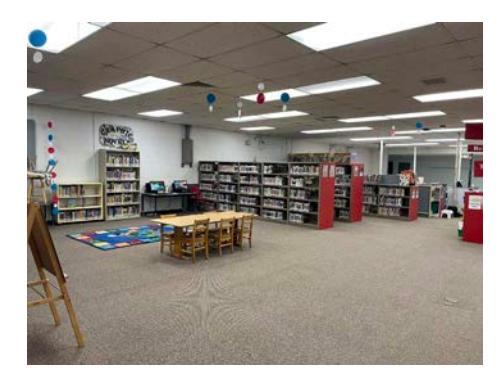
Traditional Library

The centrally located Library space is a large space that has a lot of potential. It is open to both the east and west hallways, creating a good connection to the classroom areas. While there is adequate space, the space could use a face lift. The carpet is a broadloom and starting to bubble up in places creating tripping hazards. The walls were recently repainted, which helped, but could be enhanced with more color. The function of a library has transitioned

to much more than just a warehouse for books. The library space is setup to be a traditional library which can limit its potential as an educational hub of the facility that truly becomes an active destination. A renovation of this space to include modern furniture, new flooring, ceiling and lights, would help to enhance the function and make this space more inviting.

There is limited natural daylight in the current LMC. Recommend adding a skylight to the space could help ehance the feel of the space and bring in daylight.

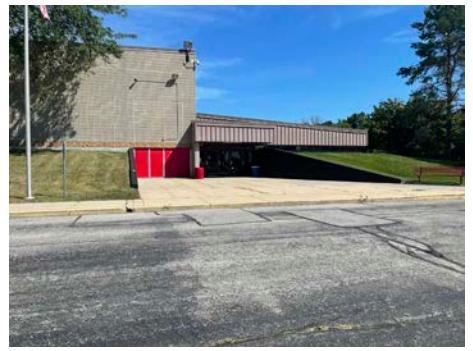
The main entry to the building is slightly more recognizable from the other entrances to the school by the use of signage and wider spaced concrete wing walls. The earth berms around the building and concrete wing walls tend to make all the entries look the same.

Main Entry to the Building

The Jr/Sr High School was constructed prior to a two stage entry through the office. With today's school security needs, this is a high priority that should be addressed. All visitors at non-peak times should be routed through the main entry to the office reception area. A direct line of sight to the vestibule where a visitor is allowed access is also recommended. A vestibule/entry addition or office reconfiguration is recommended to solve this secure entrance need.

With a remodel of the entry a new canopy could be added to the exterior of the building to signify the main entry more. A new canopy can create an identity for the school, bring color and updated lighting to the main entrance.

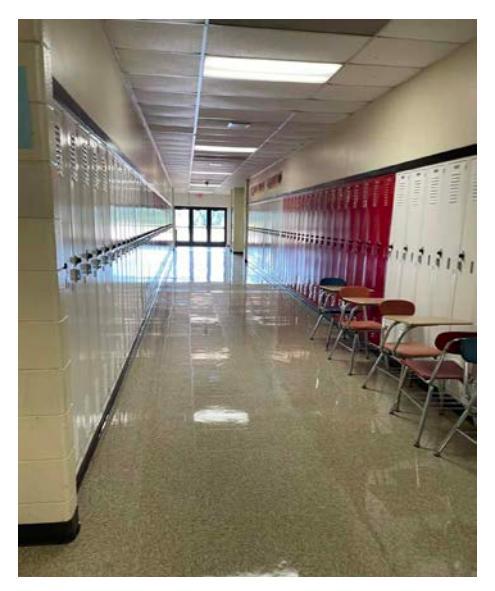
Typical Hallway

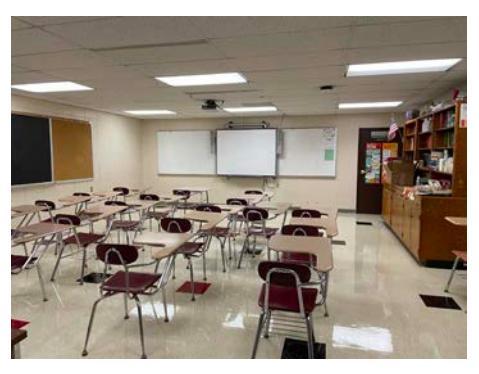
Typical Classroom

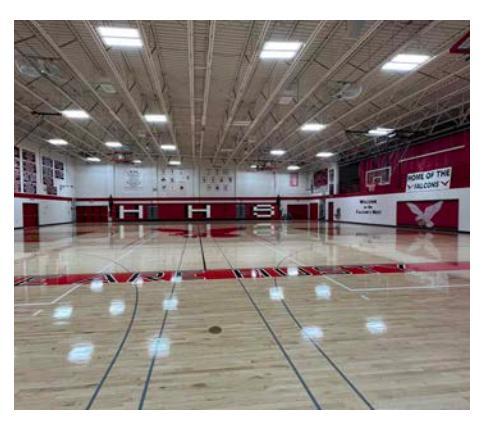
Gymnasium

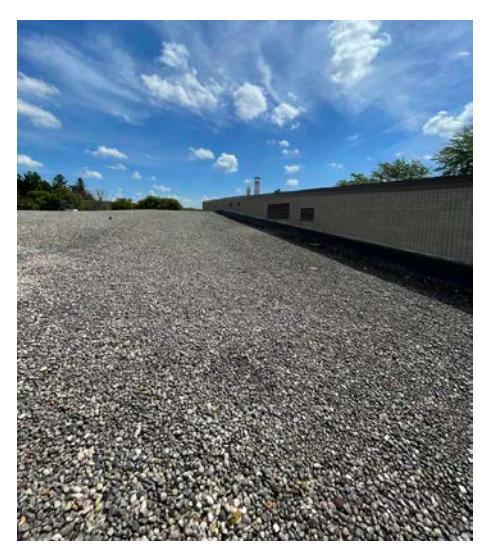
The roof system is a single membrane with ballast on a sloped metal roof deck and structure. The roof drains over the roof edge with a few scuppers along the perimeter. The water free flows down the large fascia to grade. A roof system is expected to last around 20 years. The Jr/Sr roof was replaced once in 1998, now 24 years ago. The roof is past the end of its life and leaking in certain spots. With ballast on the roof it is often hard to identify where the leak is happening. Our recommendation would be to replace the roof with a new single adhered membrane, add additional insulation to meet the energy code, and install gutters to help collect and control the water coming off the roof to get it away from the exterior wall.

Existing Ballasted Roof

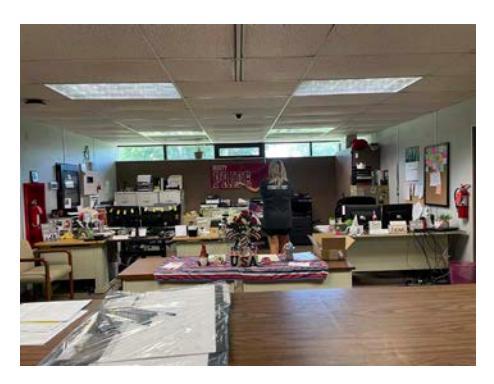
Main Office Space
AGING INTERIOR FINISHES

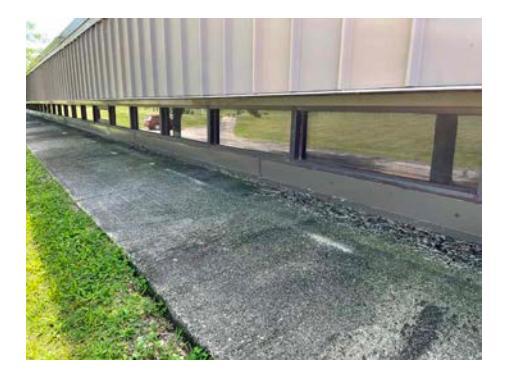
The original construction on the facility has poured concrete walls up to 6'-0" with a band of clerestory windows approximately 2'-0" tall. The concrete walls are backfilled with earth berms around most of the exterior. They allow a good amount of natural light into the classrooms along the exterior, but with the roof overhang, limited control of water, and settling of a concrete apron below the windows, water infiltration has become an issue at the windows and exterior walls. The window seals and joints are failing because caulk only lasts so long. Recommendation would be to replace the windows, install proper flashing, regrade exterior outside of the windows, and control the water from the roof better.

Exterior Celerstory Windows

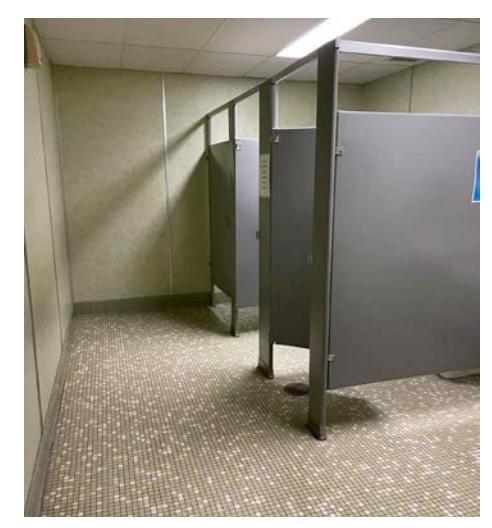
The restrooms have not been updated since the construction of the building, so accessibility was not considered. There was a single use accessible restroom added not to long ago, which is a great improvement.

Restrooms

It is recommend to update the larger restroom facilities as well, to meet accessibility standards.

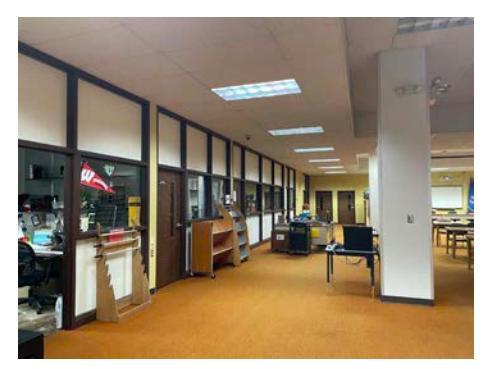
Library/LMC

There is no natural daylight in this space currently, it would be recommended to explore the addition of skylights to enhance the feel of the space along with updating all of the finishes from the carpet, to the walls and ceiling.

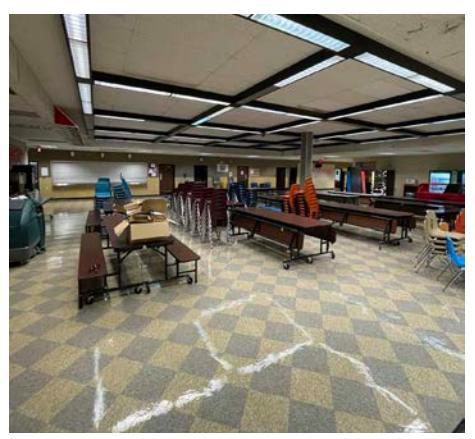
The commons and cafeteria is open to the hallways in the southeast corner of the center core. The commons/cafeteria is a gathering space in a school, it is a central hub. This space being open to the hallways is great, but the current space is lacking a little life. It has not been updated much since the facility was built. The commons lacks natural daylight being in the core of the building, but it gets a little from the main entry. Exploring ways to increase the natural daylight through a skylight would help improve the feel of the space.

Cafeteria/Commons

The space is also connected to a raised stage area that is used a couple times a year, but could be utilized more. Rethinking this space and how it could be more multipurpose would be recommended. It is possible that the raised area is no longer needed, which would allow for more cafeteria space. When a stage is needed, a portable option could be used for presentations. Being more multi-purpose could integrate it into the rest of the school, creating a central hub complimenting the LMC.

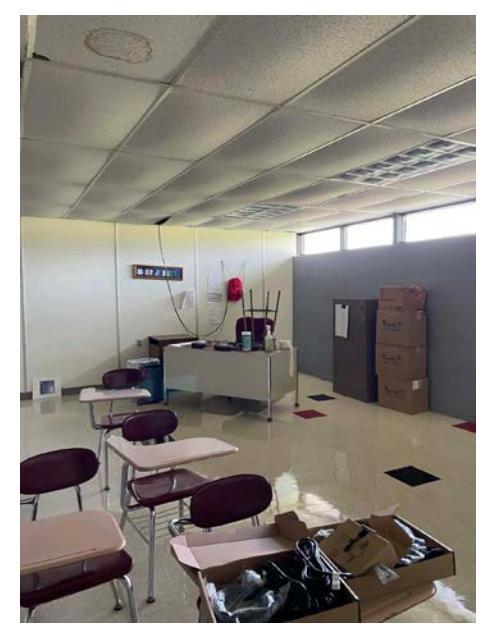
Typical Classroom

Many of the classrooms have limited built in storage for teachers. We would recommend providing new built in storage cabinets and counter space in each classroom for additional storage and work surface.

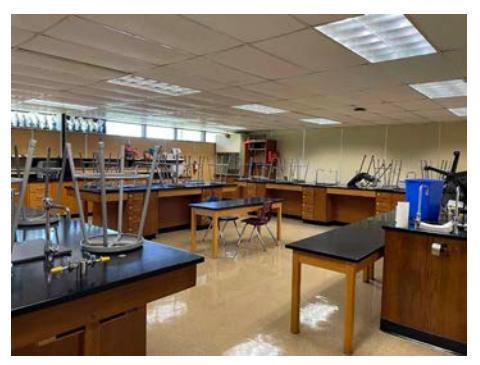
There are two science labs in the building connected by a prep and storage space for the teachers. The overall size of the science rooms is nice and they are along the exterior so they have natural light from the clerestory windows. The gas in the Chemistry Lab no longer works to some stations and so they do not utilize it at all. The lab casework is also aging and many of the draws are locked and can not be opened. Recommend replacing the lab stations with new casework, and run new gas lines to insure they are functional. This will provide the teachers the necessary equipment and space to teach the kids to the best of their abilities.

Science Lab

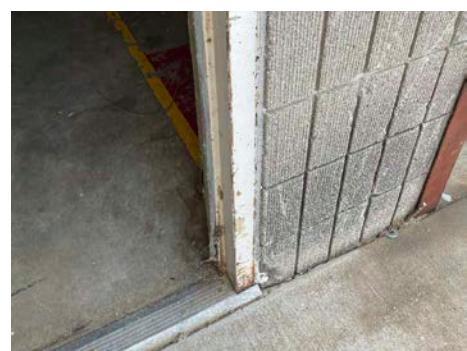
There is a lack of natural daylight as well, and a simple modification would be to replace the overhead garage door with one that has glass in it. The overhead garage door is functional, but it is showing wear and rust along with the main door next to it. The recommendation would be to replace both.

Exterior overhead garage door and main door

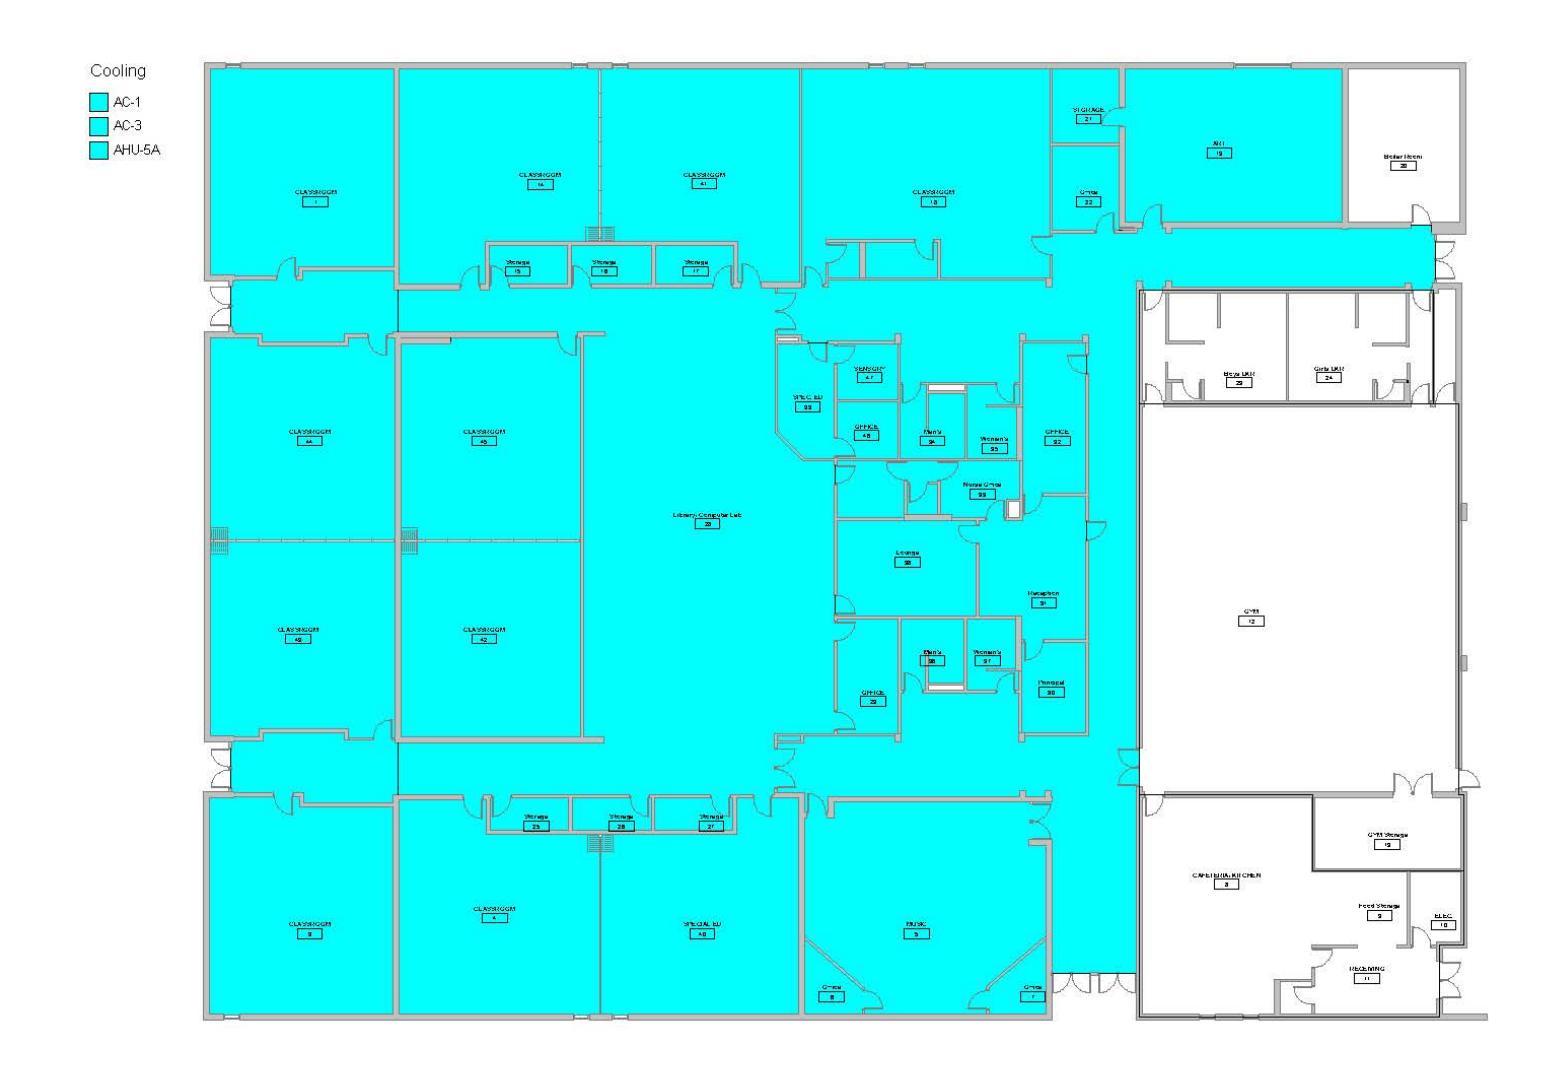
• The below building map shows the areas in the building that are currently cooled. With the exception of the gym, kitchen, and locker room areas, the entire building has cooling.

Make	Model	Capacity	Serves	Efficiency	Age
Trane	RA9006A	81 tons	Original	? EER	50 years
			Building		
			Classrooms		
Trane	RAUB-506A	5 tons	Elementary	? EER	50 years
			Office		
Trane	Unknown	15 tons	Addition	? EER	34 years
			Classrooms

• The condensing units and associated air handler evaporator coils and refrigerant piping should be replaced. These condensing units are well beyond their useful service life and utilize R-22 refrigerant. All units utilizing R-22 refrigerant shall be budgeted to be replaced with new units using R-410A refrigerant. R-22 refrigerant was phased out of production and import starting January 1, 2020 by US EPA, so providing any service to these units will be more challenging as time passes.

• Recommend servicing the air cooled condensing units at the start of every cooling season as a preventative maintenance item. Cleaning coils, recharging refrigerant, and checking operation can prolong the life of these units and prevent unwanted breakdowns during summer months.

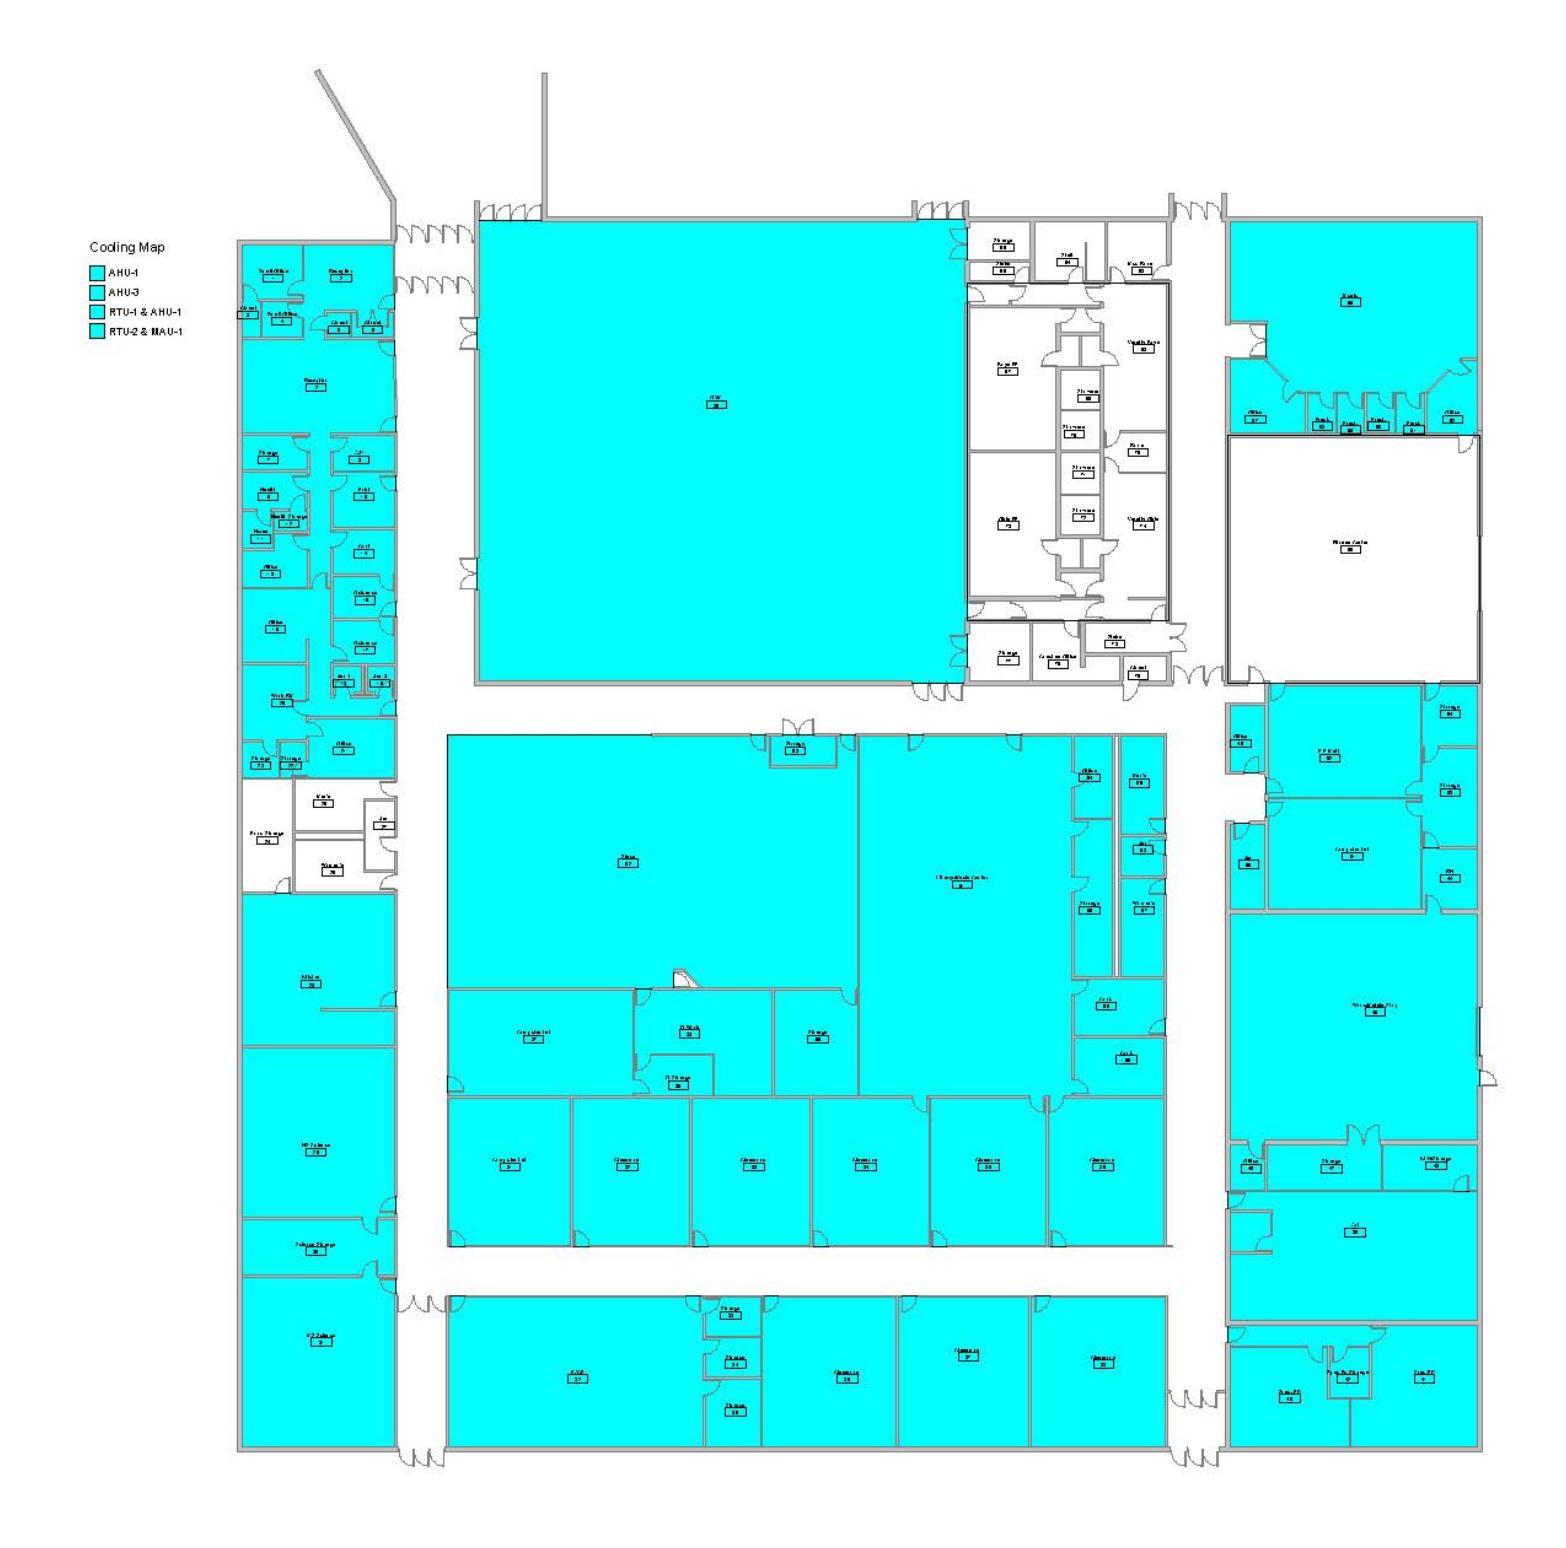
• The below building map shows the areas in the building that are currently cooled. With the exception of the fitness, wood/metal shop, and locker room areas, the entire building has cooling.

Make	Model	Capacity	Serves	Efficiency	Age
Carrier	38AKS044	36 tons	Original	? EER	19 years
			Building		
			Classrooms		
Lennox	LCA072	6 tons	Computer/	? EER	22 years
			IT Area		
Lennox	LCA042	3.5 tons	Computer/	? EER	22 years
			Shop		
			Classroom		
Trane	RAUC-406-D	4 tons	High School	? EER	42 years
			Offices		
Trane	RAUC-406-D	4 tons	High School	? EER	42 years
			Offices

• The condensing units and associated air handler evaporator coils and refrigerant piping should be replaced. These condensing units are beyond their useful service life and utilize R-22 refrigerant. All units utilizing R-22 refrigerant should be budgeted to be replaced with new units using R-410A refrigerant. R-22 refrigerant was phased out of production and import starting January 1, 2020 by US EPA, so providing any service to these units will be more challenging as time passes.

• Recommend servicing the air cooled condensing units at the start of every cooling season as a preventative maintenance item. Cleaning coils, recharging refrigerant, and checking operation can prolong the life of these units and prevent unwanted breakdowns during summer months.

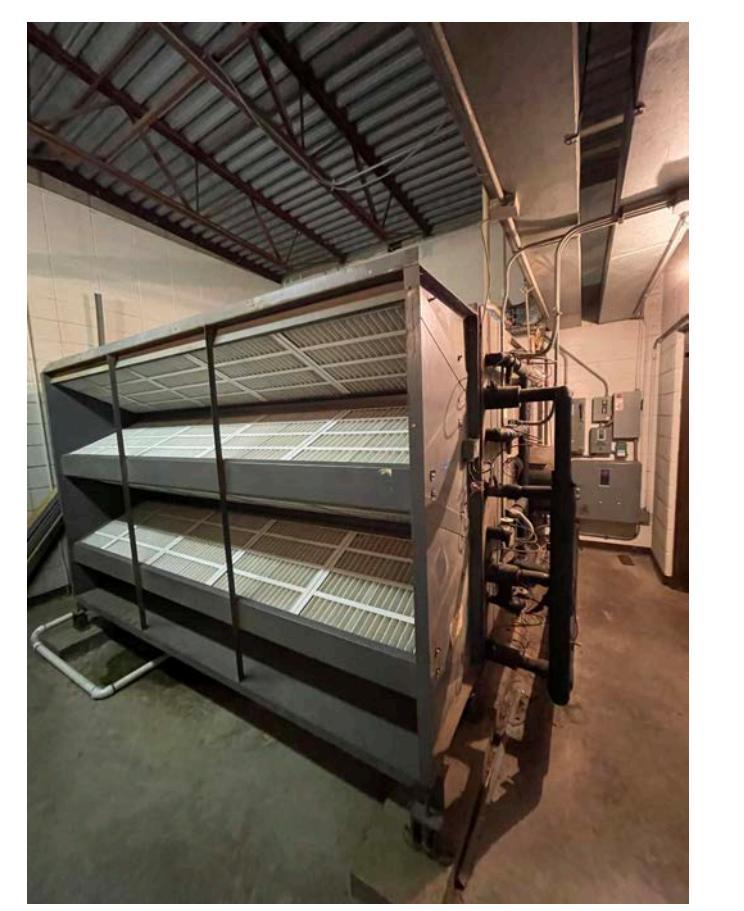
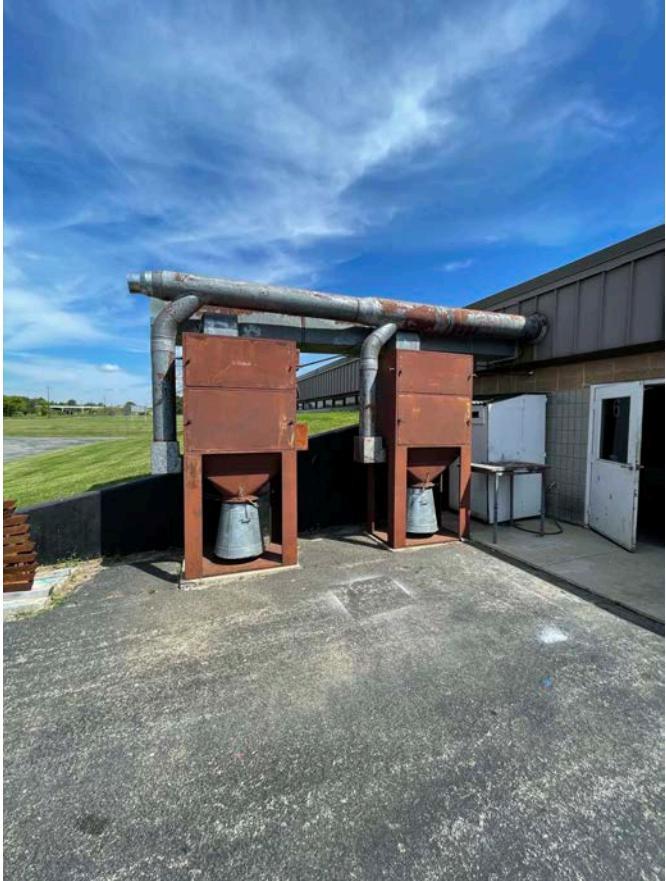
• Air handling units have an expected useful service life between 25-30 years. All of the air handling units are well beyond their service life and should be planned to be replaced with new. These units are in need of replacement as the AHU casings are showing signs of rust and deterioration.

• Recommend duct cleaning of systems to improve indoor air quality. All ductwork is original to when it was installed and to our best knowledge hasn't been cleaned in the past. Also recommend improving filtering (MERV 10 or MERV 13) to improve air quality on all installed systems.

• All of the existing exhaust fans in the building should be evaluated and replaced during this upgrade time. Many of these fans are original and beyond their useful service life. Replacing the fans will improve exhaust flow and overall function of the systems. The existing dust collector and welding exhaust system should be replaced with the upgrade in these spaces. Duct collector appears not to be functioning as it should, and there are some code deficiencies with this system that will need to be addressed if the system is modified.

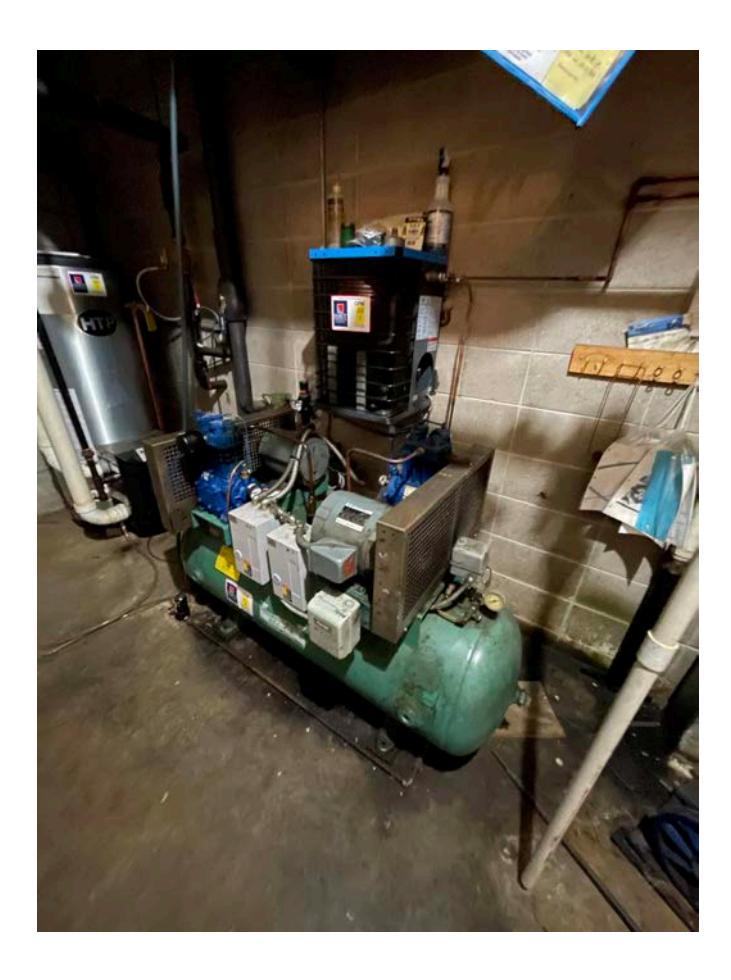
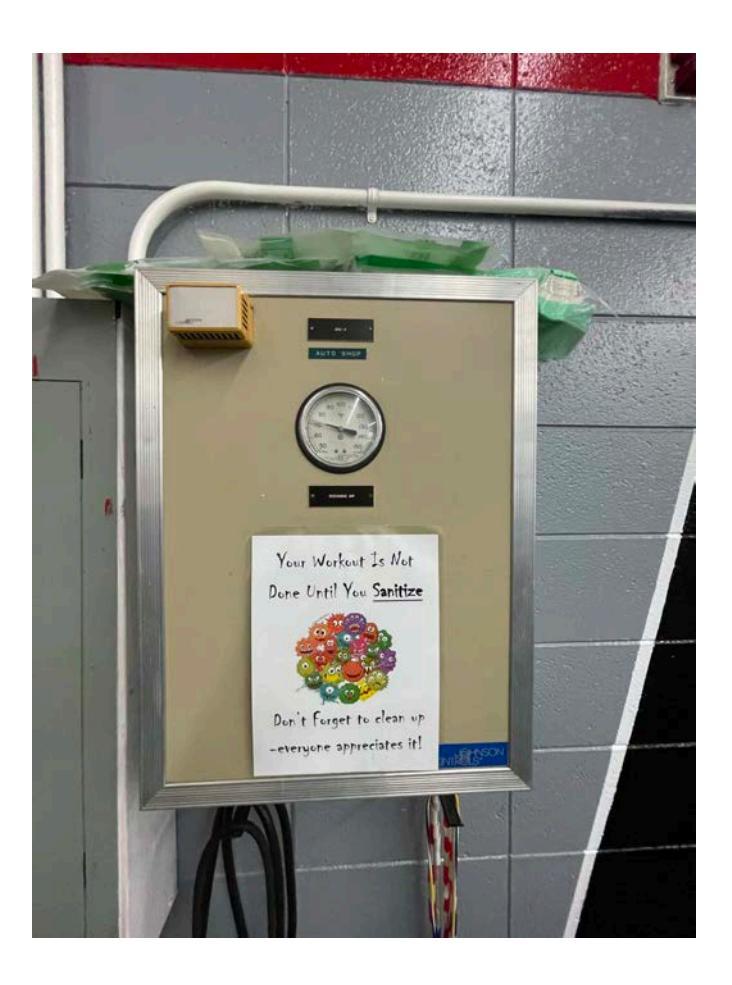
• The building is controlled by a pneumatic system that have air compressors with pneumatic air lines running to all of the controllable components. This was a typical system of its time and has become a thing of the past with newer technologies succeeding it. Typical issues that occur with pneumatic systems are loss of accuracy over time, no communication capabilities, extensive ongoing maintenance with compressors and pneumatic piping, etc. Pneumatic controls require a lot of continual calibration and maintenance to maintain accuracy.

• Recommend converting the entire building to a central building automation system with direct digital controls (DDC). DDC controls are more reliable, precise, provide feedback relative to the controller position, and can be trended for troubleshooting. When building automation systems and direct digital controls are combined, it allows for automated control of the temperature and ventilation throughout the facility. For example, the system can adjust temperatures in spaces based on season, occupancy, time of day, or day of week to reduce energy consumption. The system can also reduce the amount of outside air being brought into the building during unoccupied times, thus saving on heating or cooling that air. They can adjust boiler supply water temperatures based on outside air temperature, which works well for condensing boilers in shoulder months. This system also has the capabilities to send out alarms for break downs, failures, and hazards that many times lead to costly situations being avoided.

• There may be further energy reduction measures that could be implemented to the building. Recommend adding CO2 sensors to high occupant load spaces like gyms, LMC, Commons, Multipurpose, etc. to reduce outdoor air when not fully occupied. Similarly, occupancy or CO2 sensors could be added to classrooms to reduce outdoor air and temperature setpoints during the day if spaces aren't occupied.

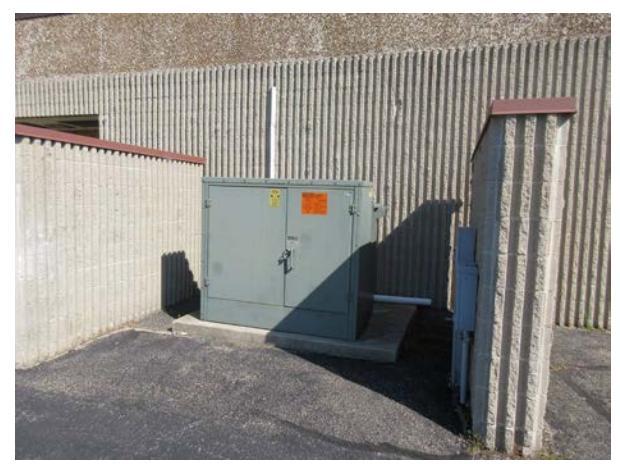
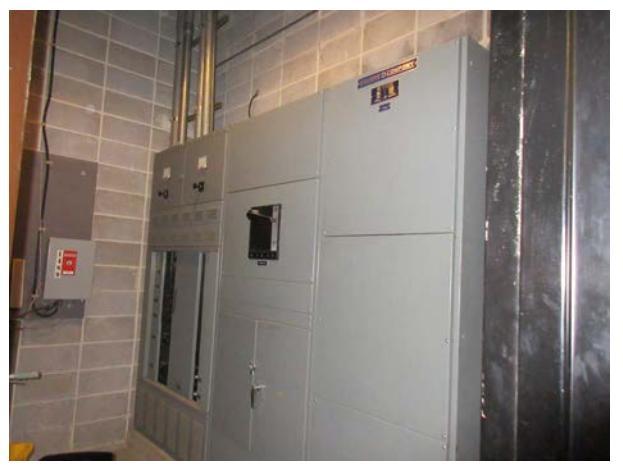
• The electrical service to main building is 120/208 volt, 3-phase, 4 wire. A Hustisford Utilities pad-mounted transformer feeds the elementary school.

• The school is equipped with a 1200A, 120/208V electric service (Square D). The main distribution panel, CT cabinet, pull section, and meter socket are located in the electrical closet near the kitchen.

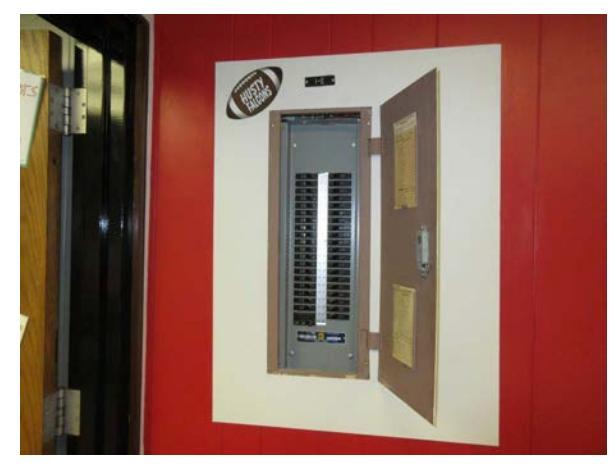
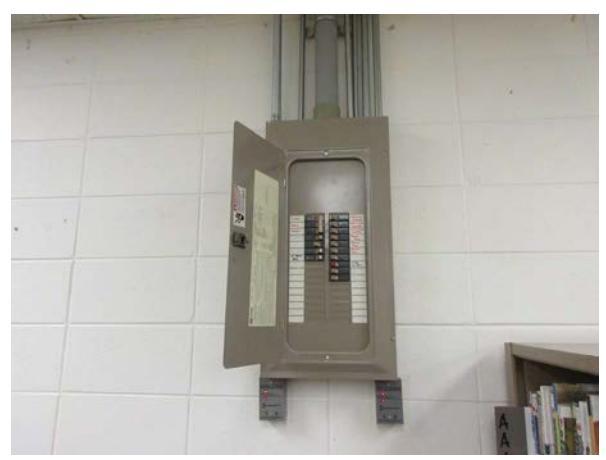
• Secondary power distribution for the school's main building is comprised of a combination of Square D panels with a couple of Cutler Hammer panels used for an upgrade. The original panelboards are in excellent condition, but they have little or no space for future breakers.

• Classrooms and the Library have extra duplex receptacles accomplished by added surface raceway.

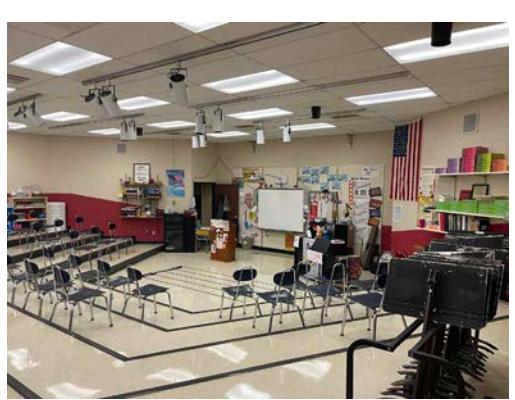
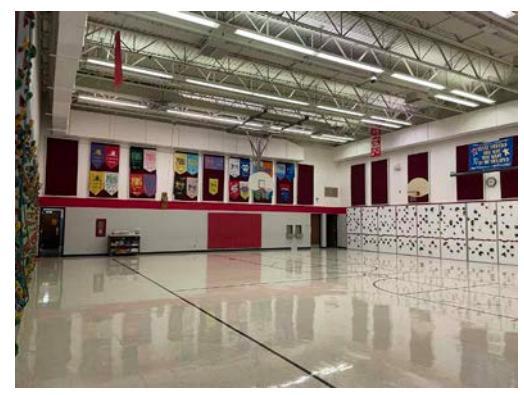
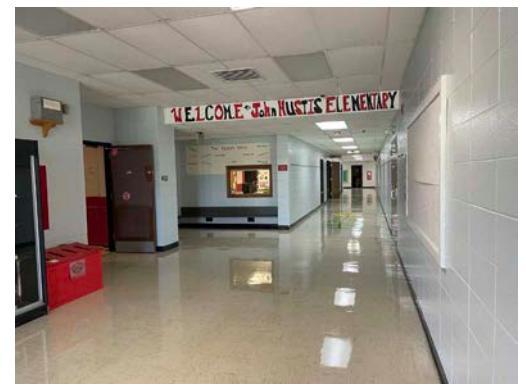
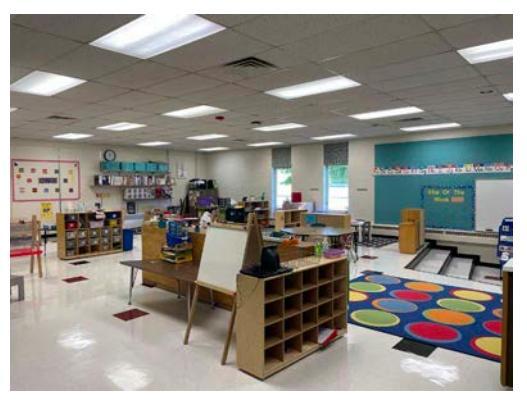
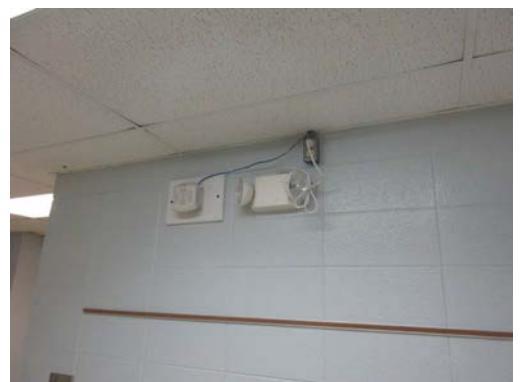
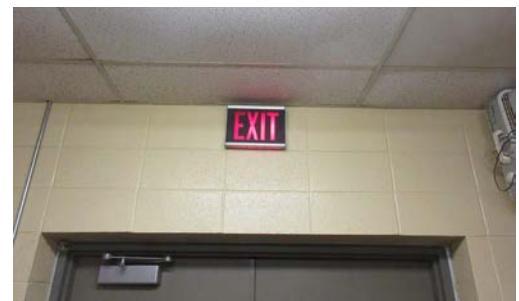
• Exit lights are black in color with red stencil with PL or incandescent lamps. Both surface and flush mounted.

• Music room is illuminated by both 2'x4' recessed troffers and stage/theatrical lighting.

• Replace all fluorescent wraps and recessed troffers with new LED type fixtures and/or replace fluorescent lamps with LED lamps.

• Recommend to remove all theatrical track lighting in music room due to non-use and owner's request.

• Replace all exit signs with LED lamp type.
5.7 FIRE ALARM AND PRIMARY LIFE SAFETY SYSTEMS ELEMENTARY SCHOOL

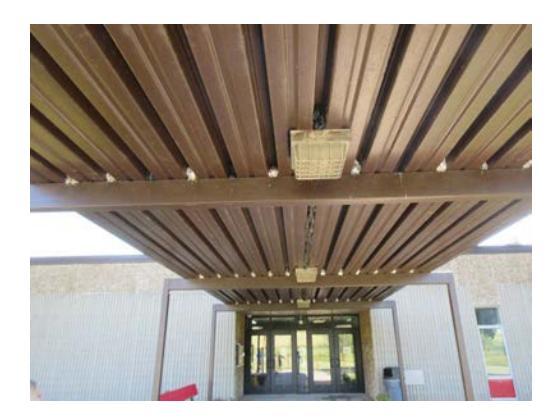
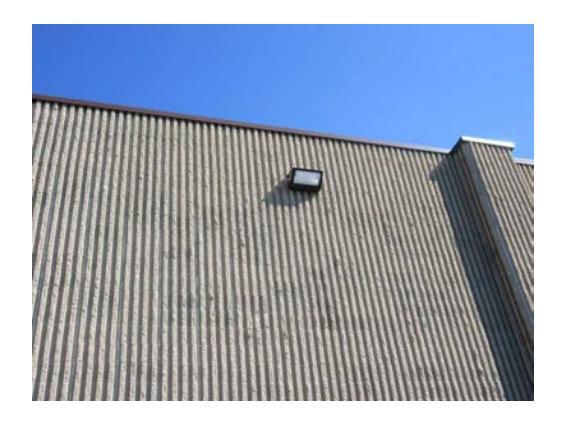
• Site and pole lighting appear to have been upgraded to LED lamp fixtures.

• Main entrance wall pak appears to be LED and controlled by internal photo-eye.

• Soffits and entries are illuminated by recessed exterior can light.

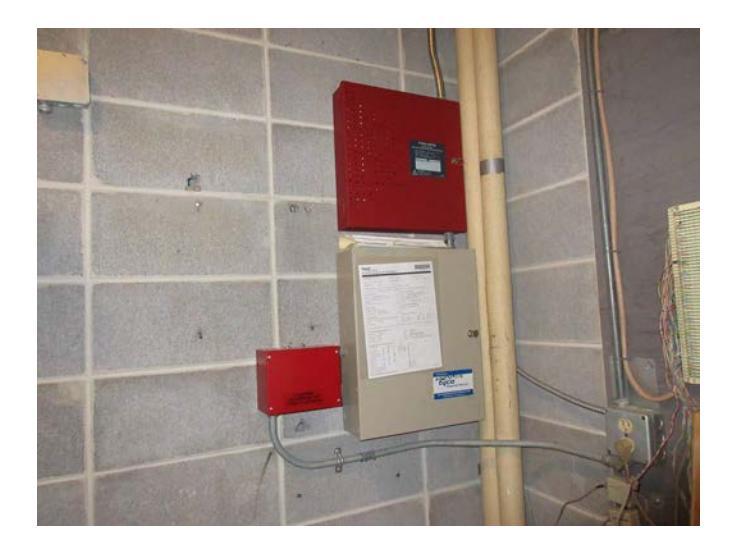
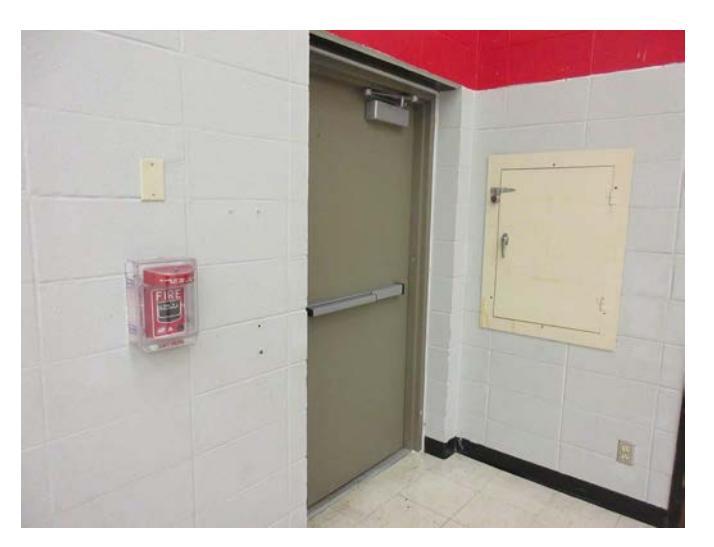
• Some heat detectors are located throughout the facility.

• The fire alarm system is monitored by an outside company (Johnson Controls).

• The addressable fire alarm system is adequate and code compliant. The system has just recently passed inspection.

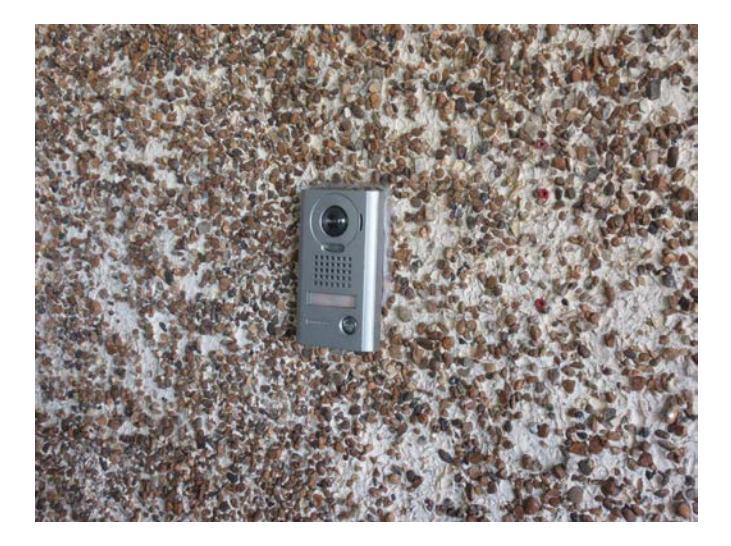
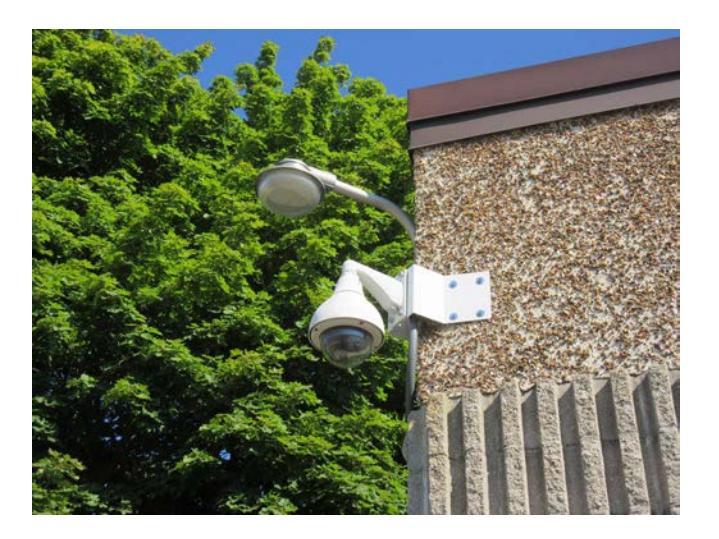
• There is an Aiphone door entry intercom system at the main doors. Buzz-in entry at main office.

• A key fob entry system at main door and secondary exterior exit/entry doors, just recently added to the facility.

• Recommend to have a secure entry vestibule adjacent to main office.

• Recommend a "shooter/intruder" alarm system is in place at the school with 911 direct initiating buttons in each classroom and main office for "Lockdown Process", and intruder lock down security strobes in most corridors.

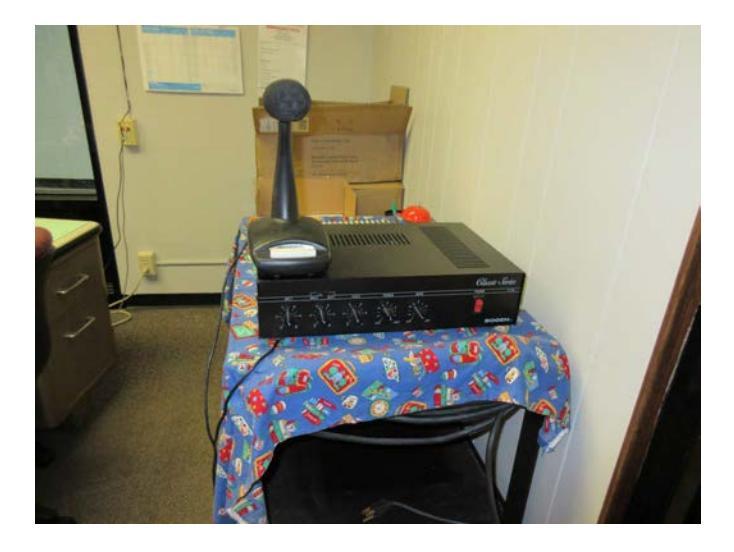
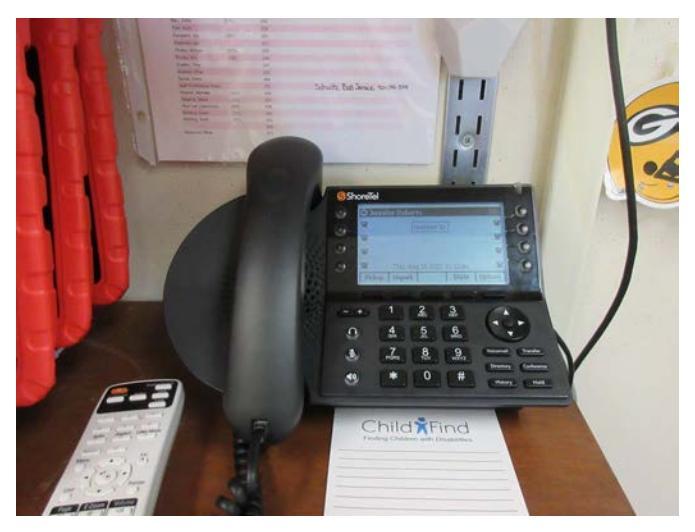
• An IP telephone system is in place and can be used for classroom paging and outside line calls, but some spaces lack an IP phone. ShoreTel telephone system.

• Bell scheduling system is accomplished through a Simplex program/timer located in teacher's lounge.

• Existing building speaker system should be replaced both at head-end and speaker locations.

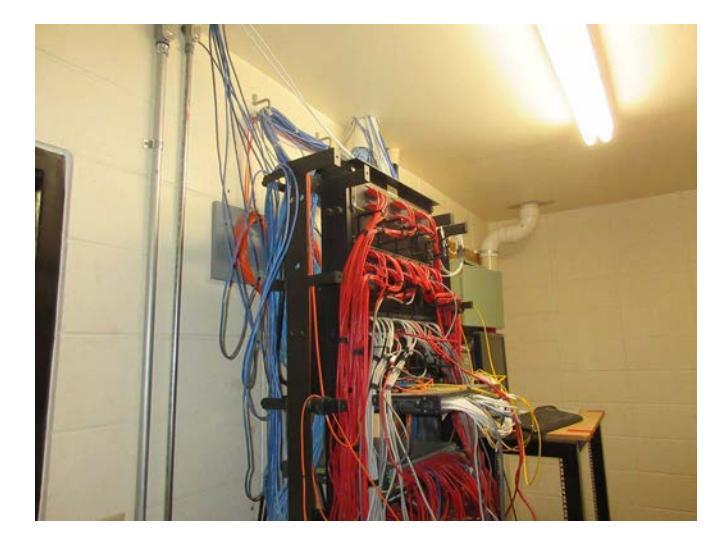
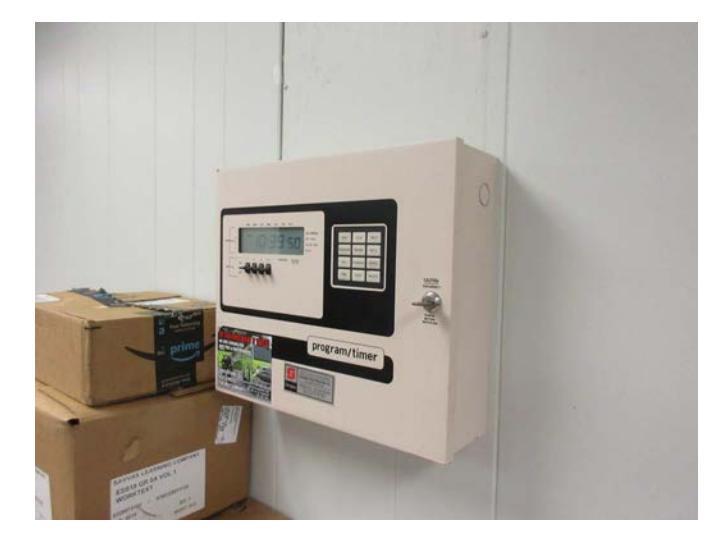
• Added data outlets are accomplished through surface raceway and power poles in classrooms and computer lab.

• There is no need for computer networking upgrades.

• Install a cable tray in main hub room for cable management.

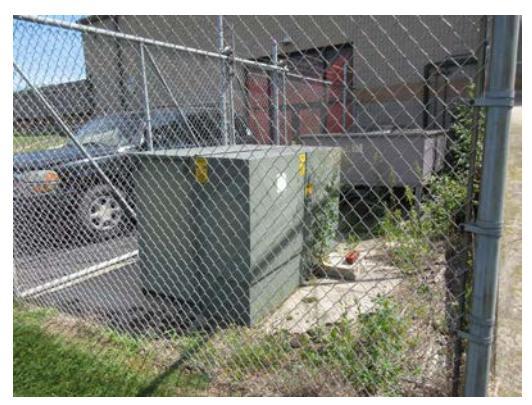
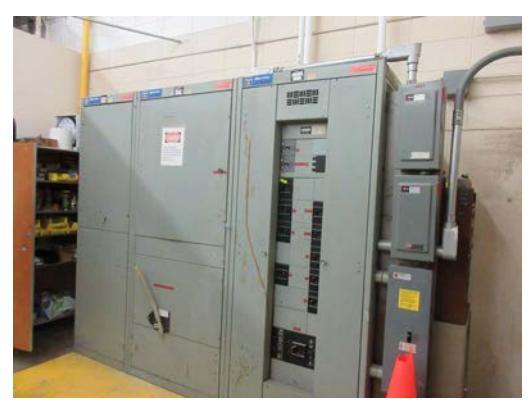
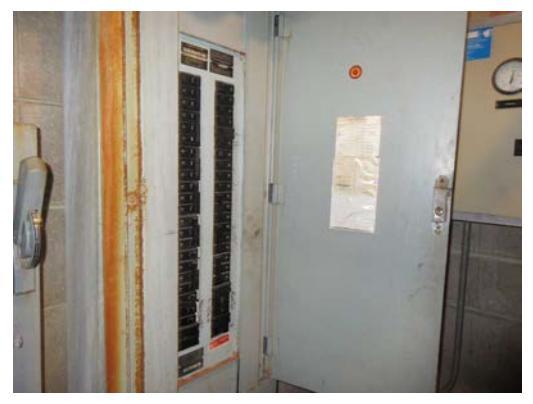
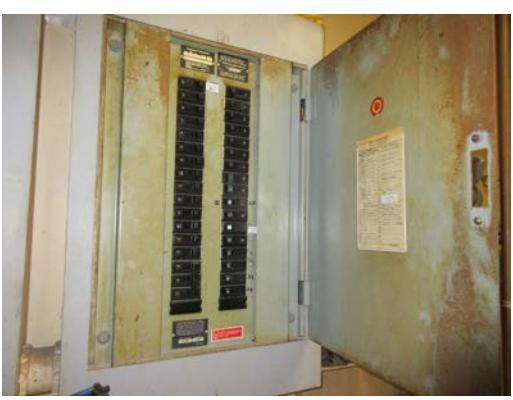
• Secondary power distribution for the schools main building is comprised of a combination of Westinghouse panels, with a couple of Cutler Hammer panels used for an upgrade. The original panelboards are in rough condition, and have little or no space for future breakers.

• Install new secondary panelboards and feeders for any future expansion.

• Recommend to install added surface raceway for additional receptacle power in class rooms and common spaces where minimal outlets are located.
