September 2022

Hustisford School District 2022 FACILITY ASSESSMENT REPORT

Hustisford School District	1 I Summary Statement	4-7
845 South Lake Street Hustisford, WI 53034	2 I Overview	8-15
ARCHITECTURE ENGINEERING INTERIOR DESIGN	3 Site Evaluation	16-21
HSR Associates, Inc.	4 I Building Program Spaces	22-41
100 Milwaukee Street	Elementary School Jr/Sr High School	24-31
La Crosse, WI 54603		32-41
KRAEMER BROTHERS Kraemer Brothers	5 I Building Systems/Engineering HVAC Systems Electrical Systems	42-87 44-67 68-87
925 Park Ave

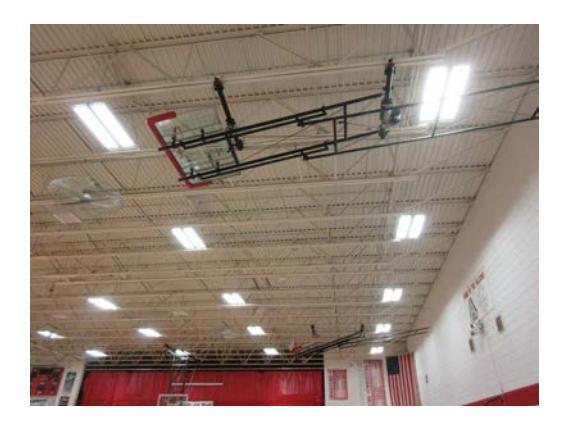
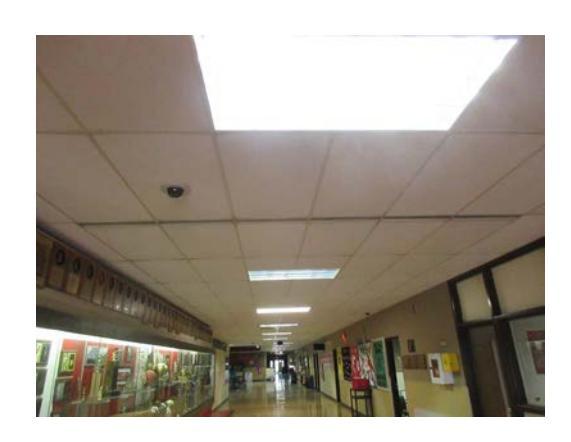
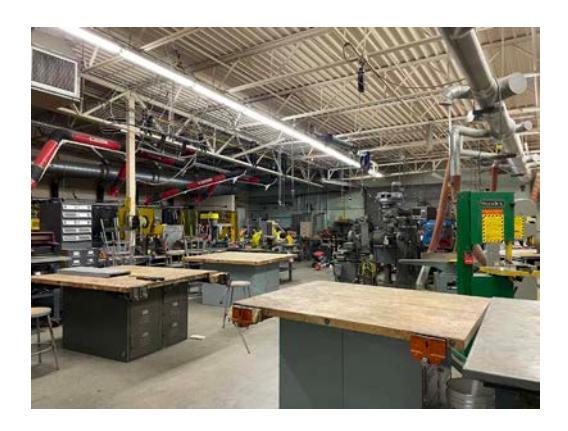
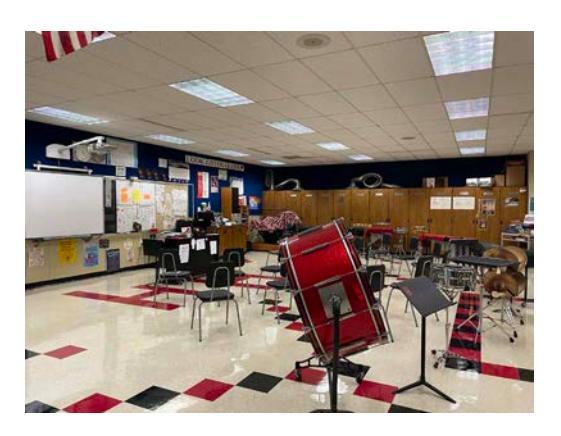
• The Gymnasium is illuminated by 6-lamp fluorescent high bay fixtures. Switch bank of 3-way switches at gym entrance doors.

• Emergency egress lighting is accomplished by battery back-up 1 and 2-head emergency lights. Also by combination exit / egress lights.

• Exit lights are white in color with red stencil with LED lamps. Some are equipped with emergency egress "eye lids".

• Replace all fluorescent wraps and recessed troffers with new LED type fixtures and/or replace fluorescent lamps with LED lamps.

• Recommend to use LED high-bay lighting fixtures in the Gymnasium, based on longer lamp life, less maintenance, and Focus on Energy rebates.

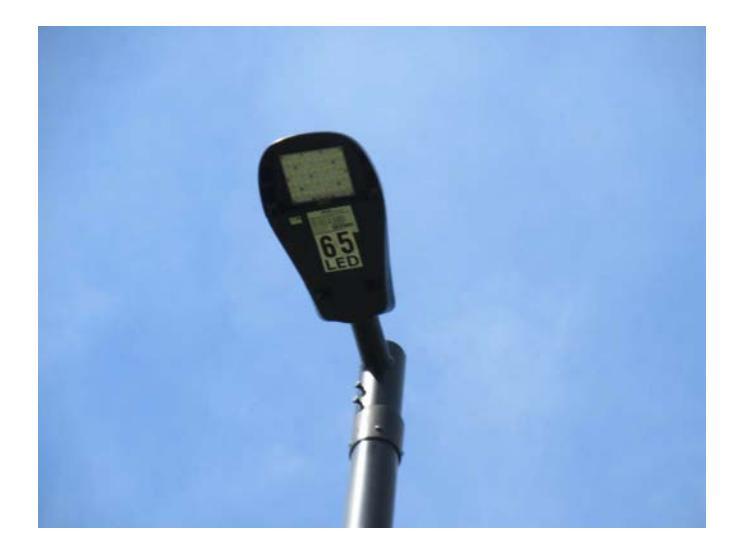
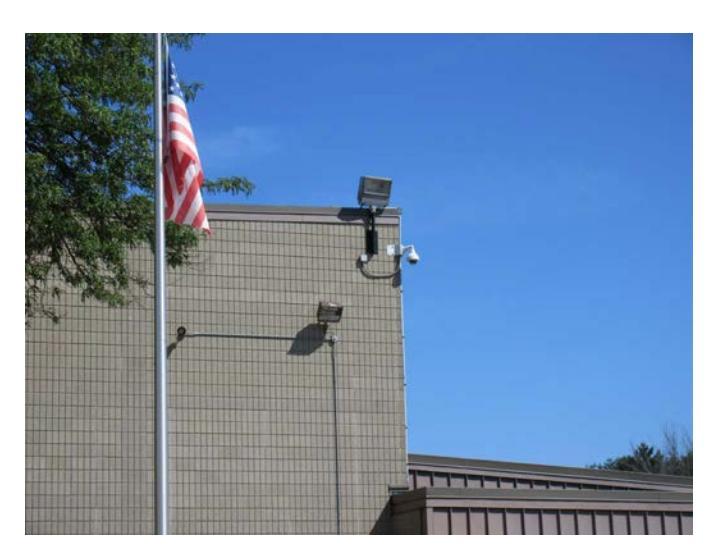
• Site and pole lighting appear to have been upgraded to LED lamp fixtures.

• Main entrance is illuminated by recessed metal halide cans and building wal-paks.

• Secondary entry doors are illuminated by wall paks with an internal photo-eye as control.

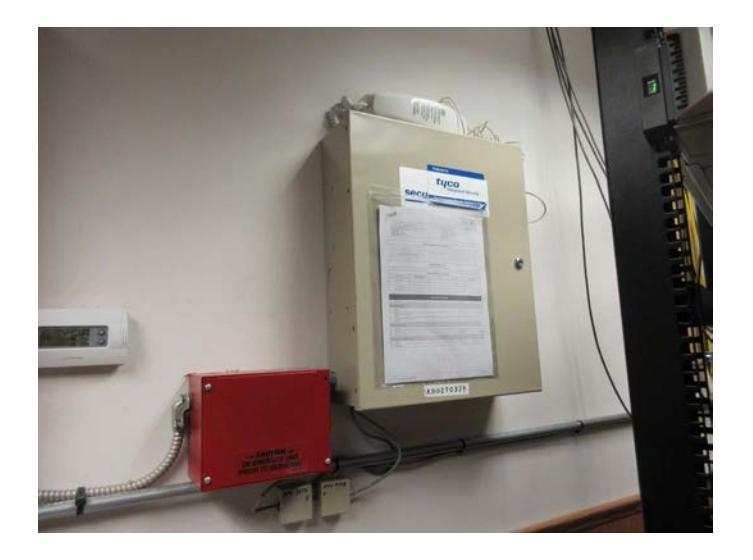
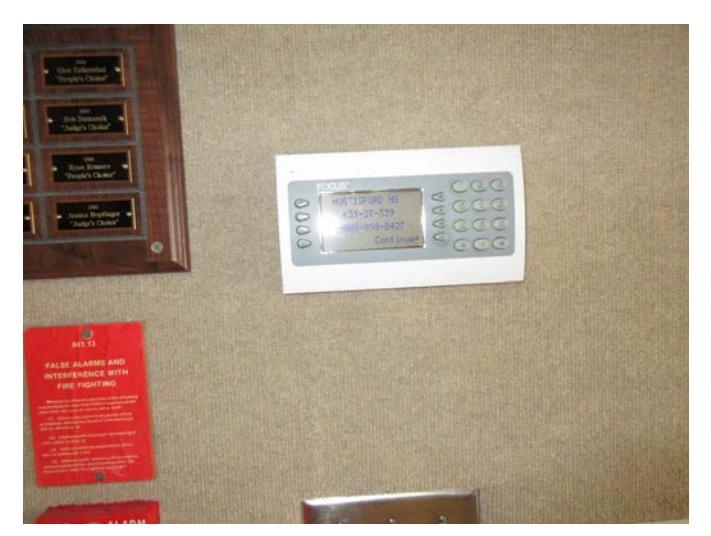
• Some heat detectors are located throughout the facility.

• The fire alarm system is monitored by an outside company (Johnson Controls).

• The addressable fire alarm system is adequate and code compliant. The system has just recently passed inspection.

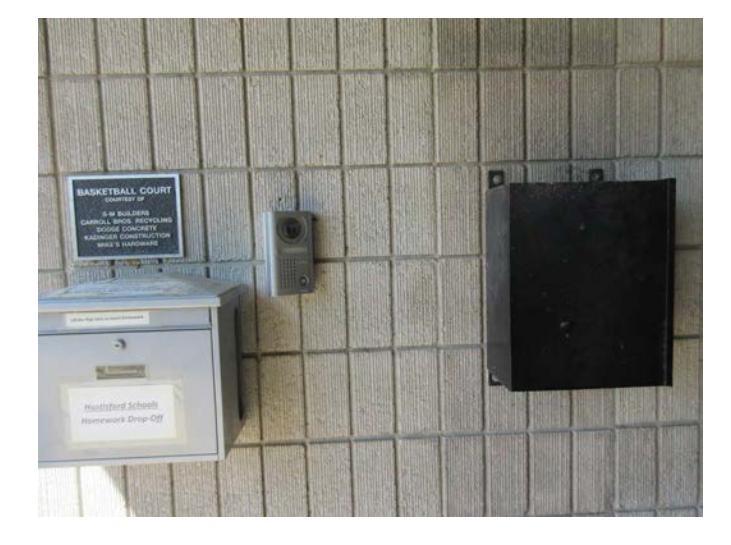
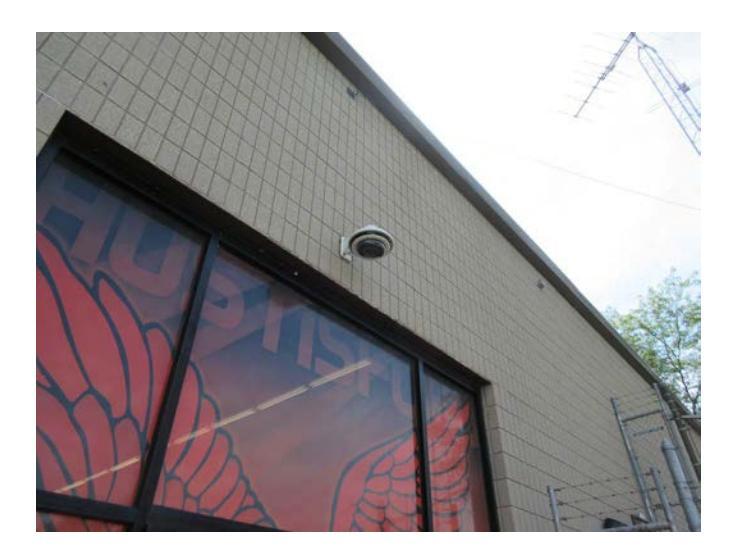
There are security surveillance cameras at the main entry, building mounted for area view, gymnasium, library, and corridors. Viewing monitor inside main school office at both receptionist and principal's desks.
There is an Aiphone door entry intercom system at the main doors. Buzz-in entry at main office.

• A key fob entry system at main door and secondary exterior exit/entry doors.

• Recommend to have a secure entry vestibule adjacent to the main office.

• Recommend a "shooter/intruder" alarm system is in place at the school with 911 direct initiating buttons in each classroom and main office for "Lockdown Process", and intruder lock down security strobes in most corridors.

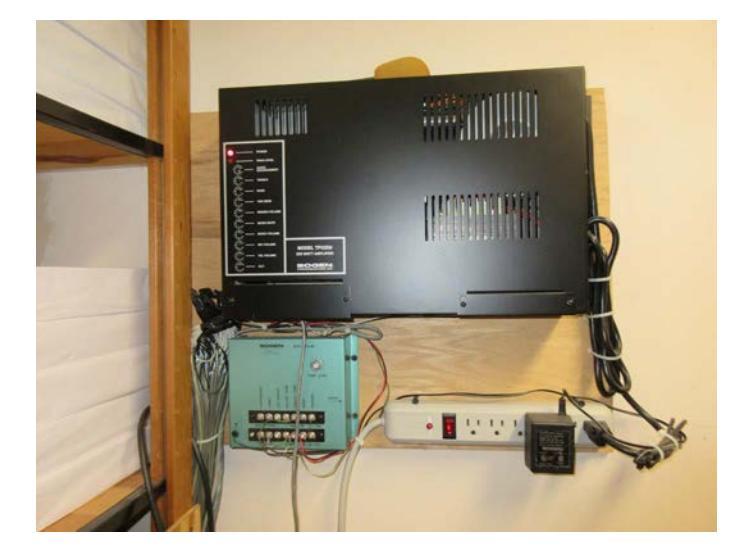
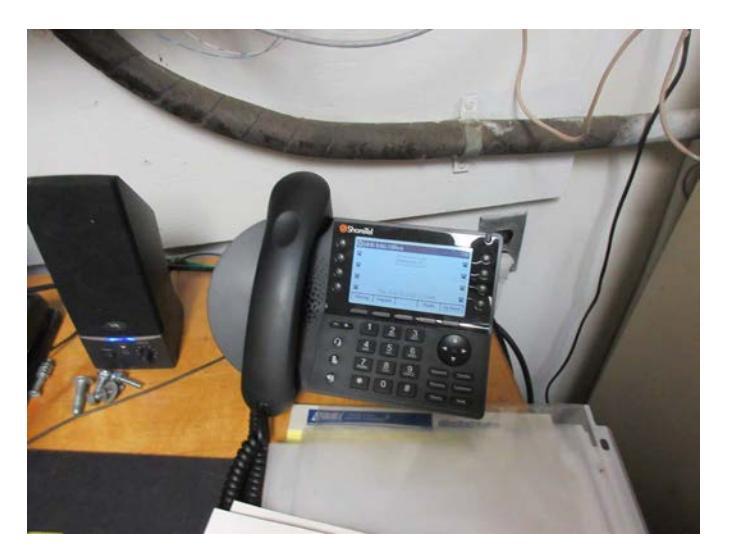
• An IP telephone system is in place and can be used for classroom paging and outside line calls, but some spaces lack an IP phone. ShoreTel telephone system.

• Bell scheduling system is accomplished through a Simplex program/timer located in the main office.

INTERCOM/PUBLIC ADDRESS/BELL SCHEDULING SYSTEM RECOMMENDATIONS

• Existing building speaker system should be replaced both at head-end and speaker locations.

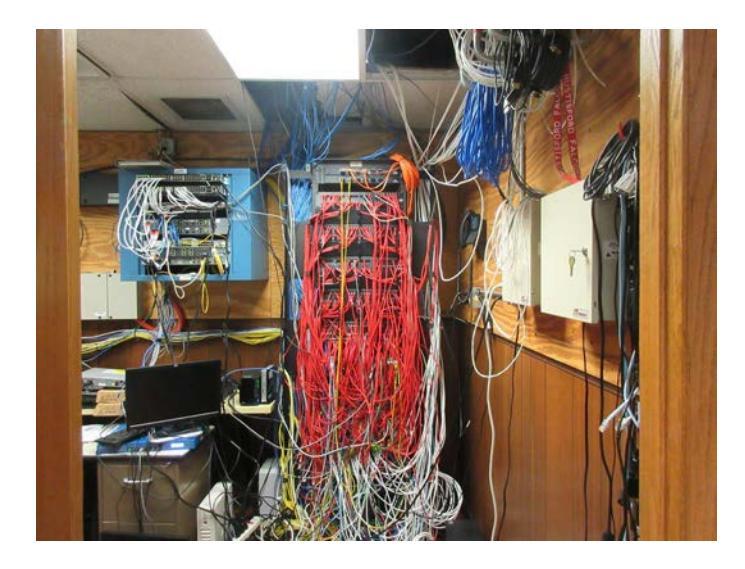
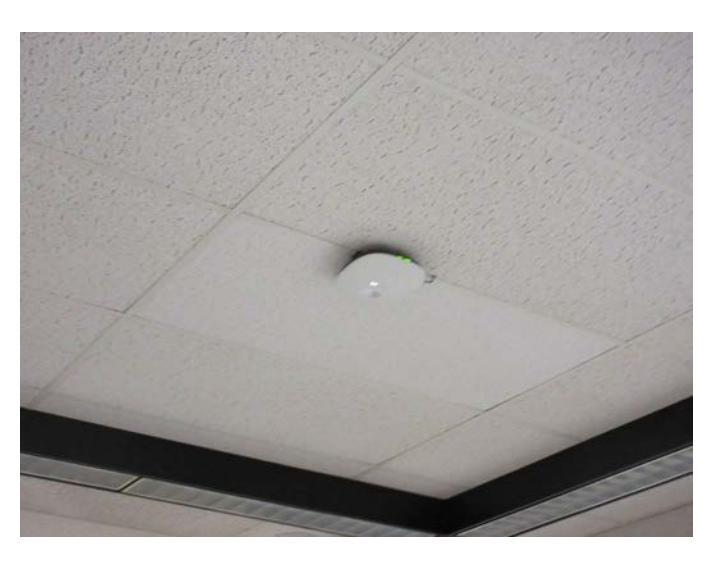
• Surface raceway is used for the computer lab and added to some areas.

• There is no need for computer networking upgrades.

COMPUTER NETWORKING RECOMMENDATIONS

• Install a cable tray in main hub room for cable management.

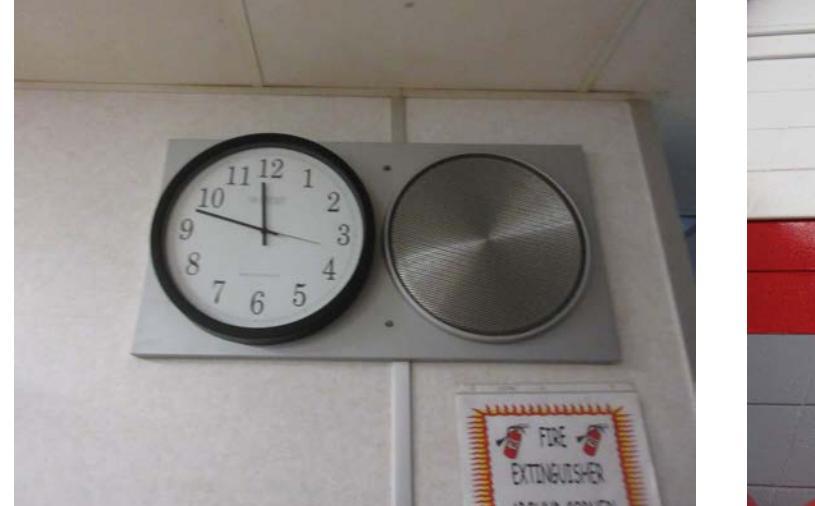
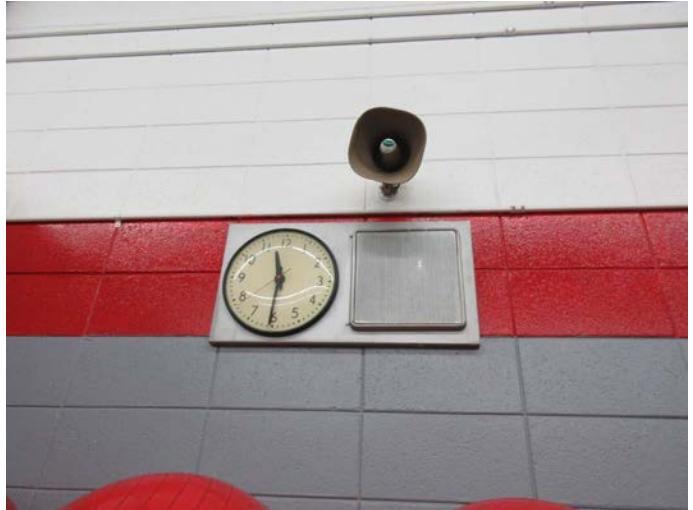
Clocks are located in every classroom and main office. The clocks are

14" analog and are stand-alone batteries.

CLOCK SYSTEMS RECOMMENDATIONS

• Install a wireless clock system. A wireless system which uses a dedicated FM band frequency which is solely generated only inside said facility.

• Standardize all clock manufacturers for easy replacement and continuity.

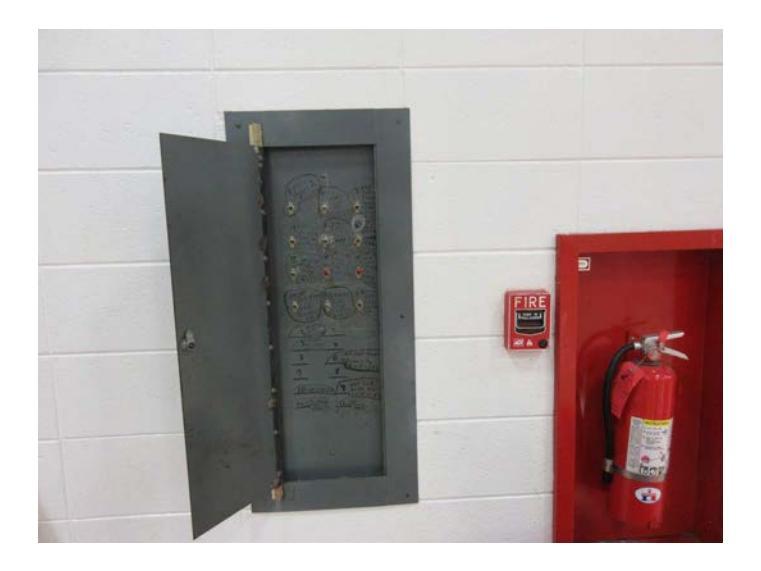
• Gymnasium basketball backboard controls are a toggle switch control cabinet set in the gymnasium wall.

GENERAL SYSTEMS RECOMMENDATIONS

• Recommend to provide a centralized touch screen control panel in gymnasium. Panel where lights, fans, and backstops, etc. can be controlled from.
